HOUSE of REPRESENTATIVES

Appropriations Requests for Legislatively Directed Spending Items

4. Name of the entity that the spending item is intended for:
Grand Rapids Art Museum
5. Physical address of the entity that the spending item is intended for:
101, Monrow Center St NW, Grand Rapids, MI 49503

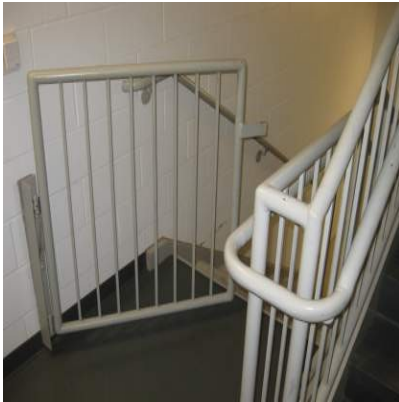
UniFormat Section: B1080.50 - Stair Railings
Name: Handrail Gate
Priority: Urgent (Past Due)
Location: Stair S-1
Manuf Type: Custom
Today's Cost: \$1,200
Observation: The hinge system is not preventing exit into basement.
Reason for Replacement: Code / Regulatory
Evaluation Rating: 4 - Most functions perform
Recommendations: Reconstruct the gate 'stop' to prevent exit to basement

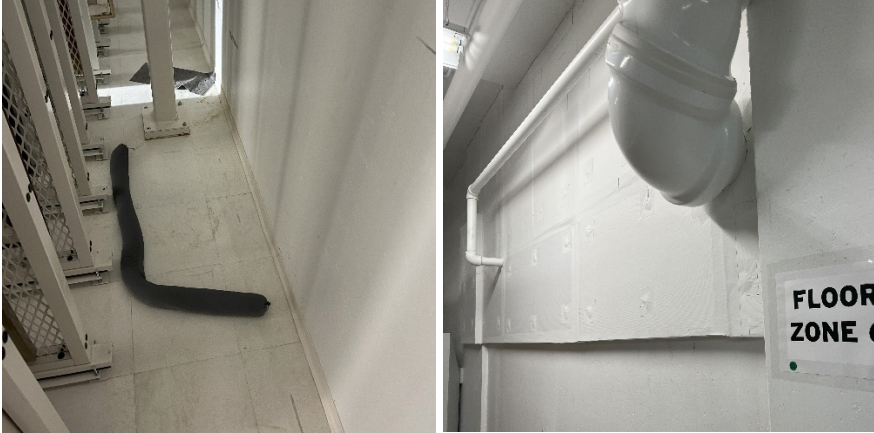
North wall of Art/Bulk Storage shows signs of water infiltration. Sliding vertical art racks north wall is leaking from above requiring a need for water absorption material on the floor.

The walls are common to the outside open court area. Investigate the base of exterior wall flashing condition.

Recommendations: Determine cause and source of water infiltration. Resolve condition.

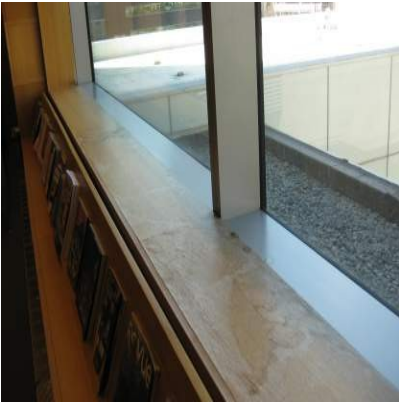
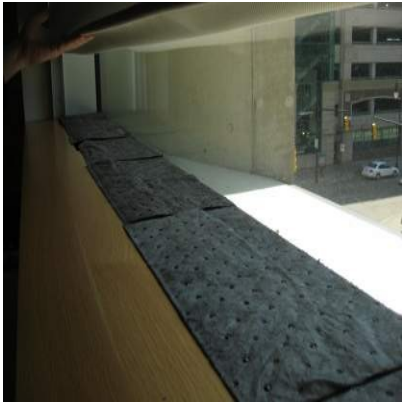
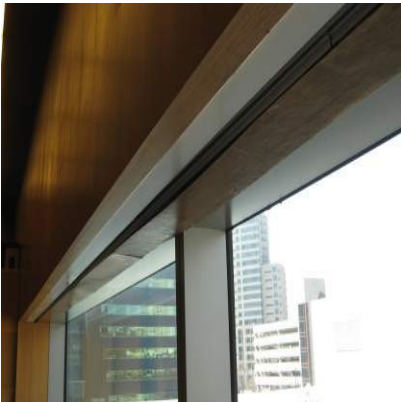
Observation: Exterior windows are set to the exterior, surrounded by concrete wall construction, in what becomes a deep pocket. The head, jamb and sill are clad with finished wood. The humidity levels in the building and the depth of the pocket resulting in a lack of air movement across the windows has caused a buildup of water on the aluminum framing. Some water is dripping from the head of the aluminum framing between the framing and the wood trim. (Per owner, the maintenance protocol is to wipe the windowsills every three hours.)

Replacement of the window system may be the only solution to eliminate the condensation.

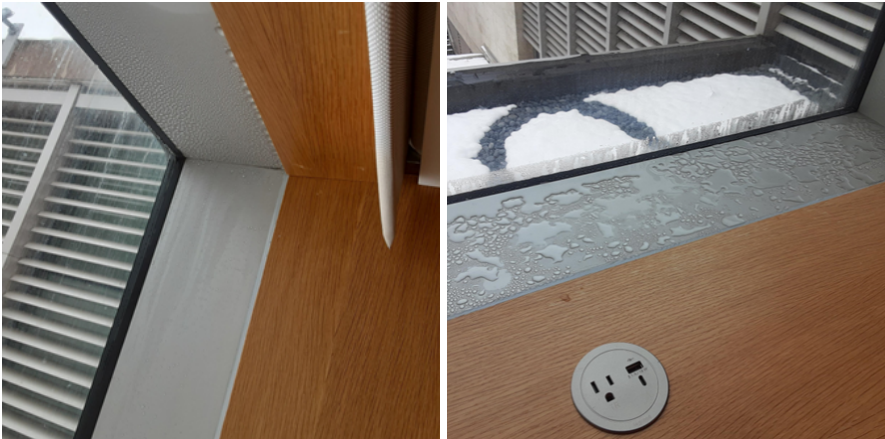
Two photos showing Winter 2024 conditions. Head on left. Sill on right.

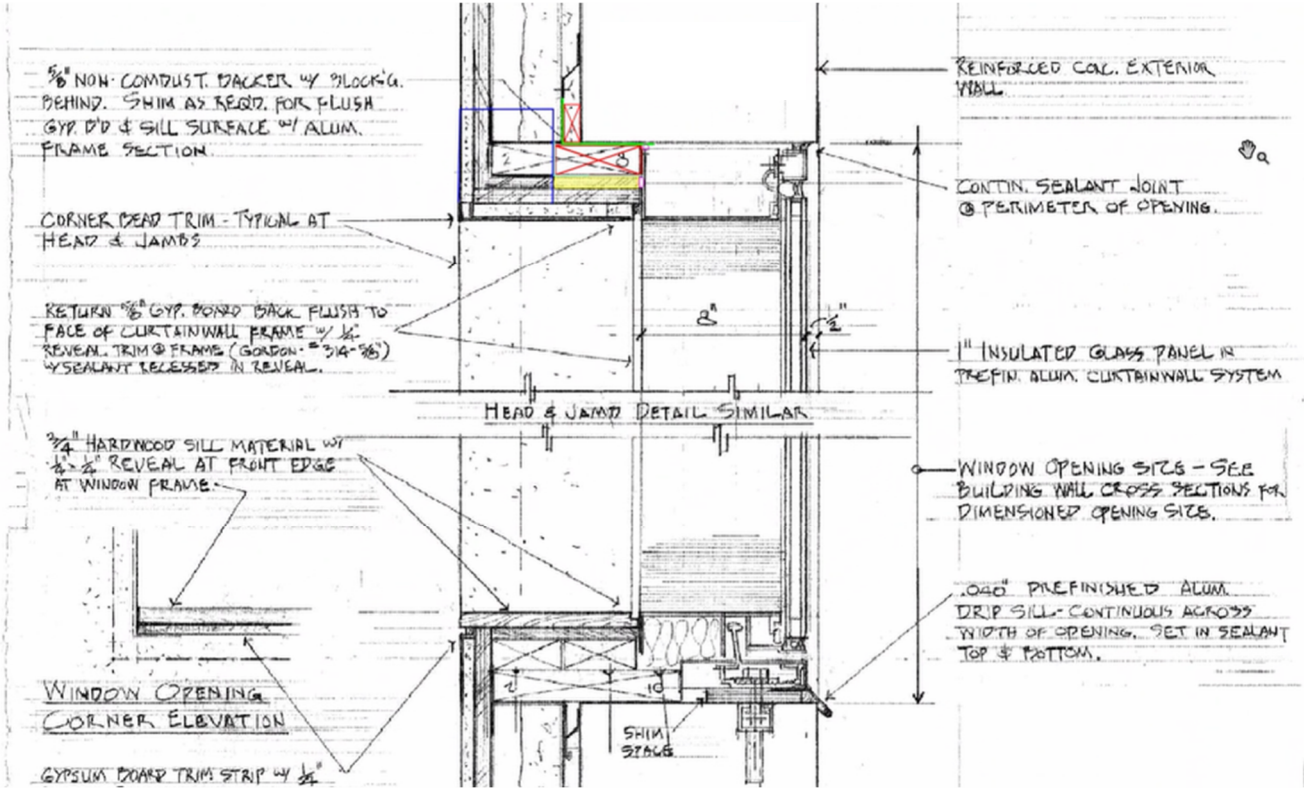
Original detail of exterior window at Library showing custom channel window system without thermal.

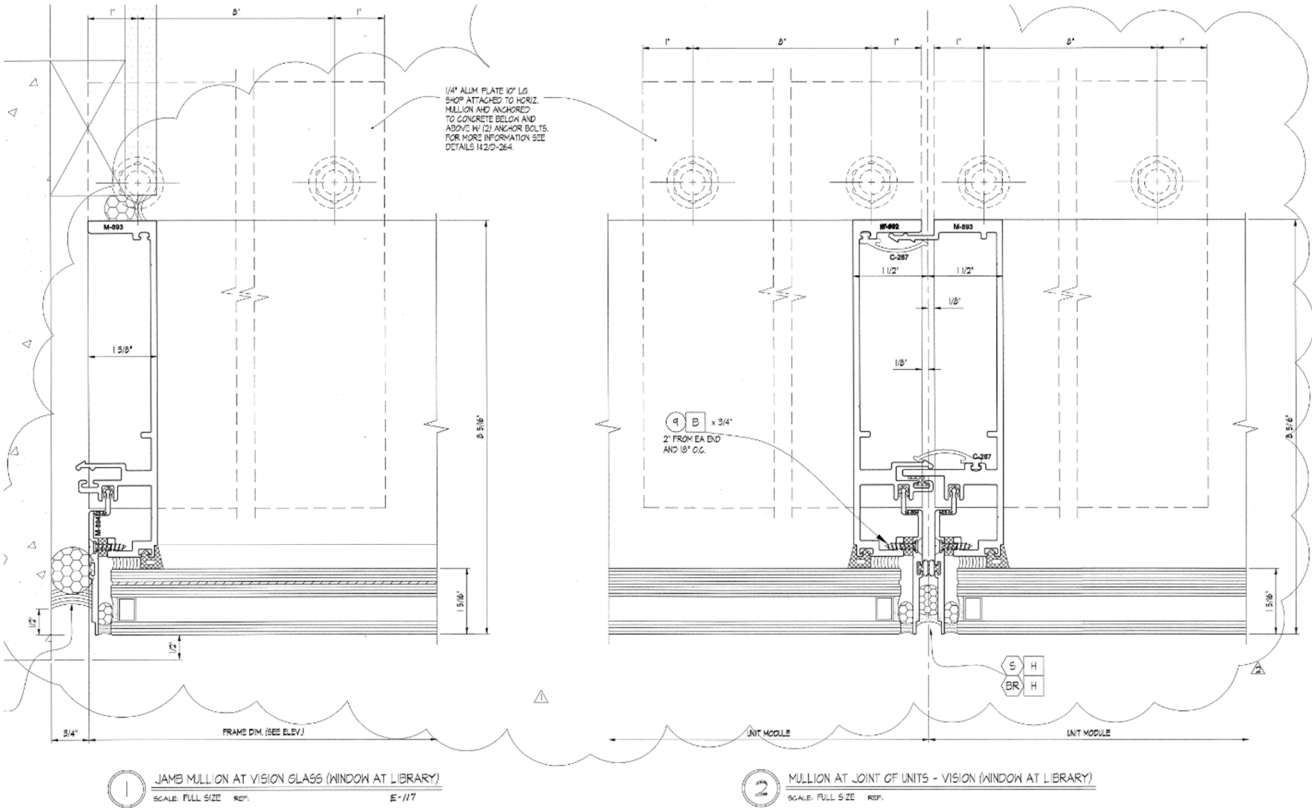
Curtainwall Shop Drawing
'Very cold' window section
without thermal breaks. A cold
path directly into building using
high humidity.

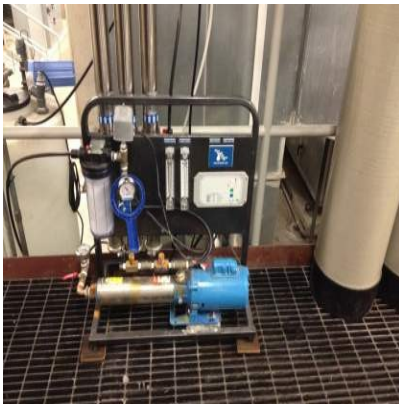
UniFormat Section: D2060.50 - Processed Water Systems
Name: Reverse Osmosis (RO) water filtration
Priority: Moderate (1 - 5 years)
Location: Mechanical Room
Manuf Type: Fliers Quality Water System
Today's Cost: N/A
Observation: Floor mounted package unit, 50gpm capacity
Reason for Replacement: Age / Useful Life
Evaluation Rating: 5 - All functions perform
Recommendations: Replace RO unit when useful life ends.

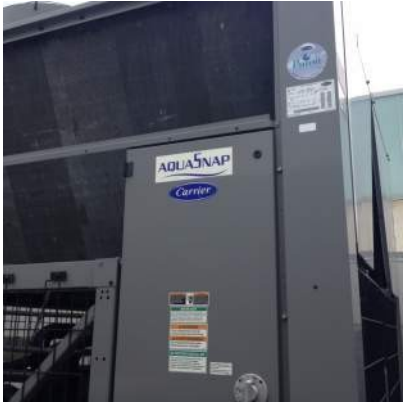
UniFormat Section: D3030.10 - Central Cooling
Name: Air Cooled Chiller
Priority: Moderate (1 - 5 years)
Location: Penthouse Roof
Manuf Type: Carrier
Today's Cost: N/A
Observation: No reported problems with Air Cooled Chillers. Chillers have a capacity of 55 tons each.
Reason for Replacement: Age / Useful Life
Energy Efficiency
Evaluation Rating: 5 - All functions perform
Recommendations: Air Cooled Chillers can be replaced with higher efficiency chillers.

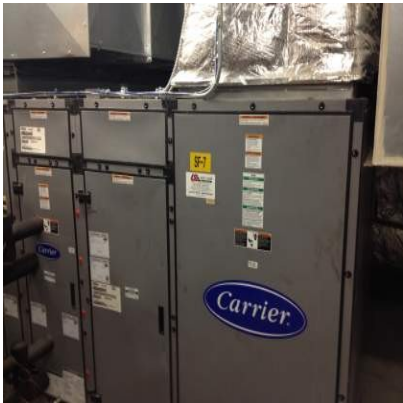
UniFormat Section: D3030.10 - Central Cooling
Name: Main Lobby Supply Fan
Priority: Moderate (1 - 5 years)
Location: Mechanical Room
Manuf Type: Carrier
Today's Cost: \$75,000
Observation: Air Handling Unit with DX cooling, hot water heating and supply fan, 16,000 cfm capacity.
Reason for Replacement: Age / Useful Life
Energy Efficiency
Evaluation Rating: 3 - Some functions do not perform
Recommendations: Replace air handling unit with more energy efficient equipment. Problems were reported with providing N+1 capacity efficiently.

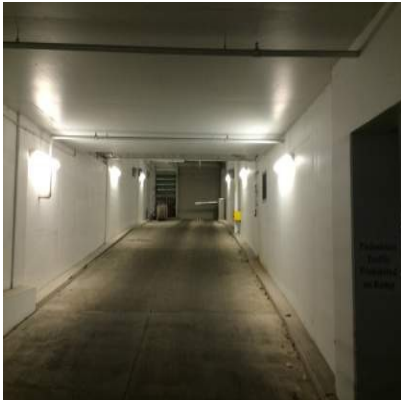
UniFormat Section: D5040 - Lighting
Name: Ramp Fluorescent wall mounted fixtures
Priority: Moderate (1 - 5 years)
Location: Parking Ramp on Basement level
Manuf Type: 2 lamp fluorescent wall mounted fixtures
Today's Cost: \$7,000
Observation: Existing wall mounted fluorescent fixtures in the ramp to the parking areas are on all hours of operation.
Reason for Replacement: Energy Efficiency, maintenance cost
Evaluation Rating: 5 - All functions perform
Recommendations: Replace the wall mounted fluorescent with an LED wall mounted fixture and incorporate occupancy sensors to reduce the light output to 50% to reduce energy usage when motion has not been detected for 15 minutes and return to 100% output upon detection of motion.

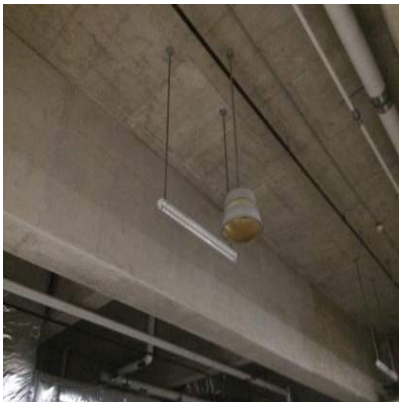
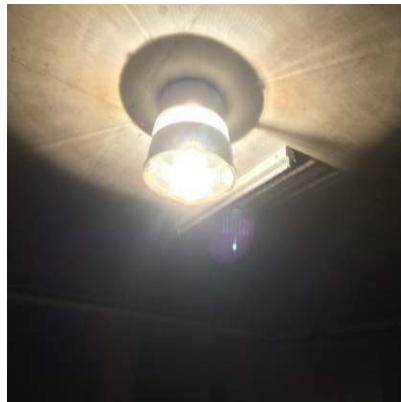
UniFormat Section: D5040.50 - Lighting Fixtures
Name: Parking Area Lighting
Priority: Moderate (1 - 5 years)
Location: Parking Lot Area in Basement Level
Manuf Type: Low Bay metal halide
Today's Cost: \$30,000
Observation: Some of the current fixtures need lamp ballast changes. Fixtures are operating at full output 24 hours a day.
Reason for Replacement: Energy Efficiency, maintenance cost
Evaluation Rating: 3 - Some functions do not perform
Recommendations: Replace the current metal halide fixtures with LED type fixtures that also integrate multi-level dimming and occupancy sensors to reduce light output and energy usage when there are no occupants in the area.

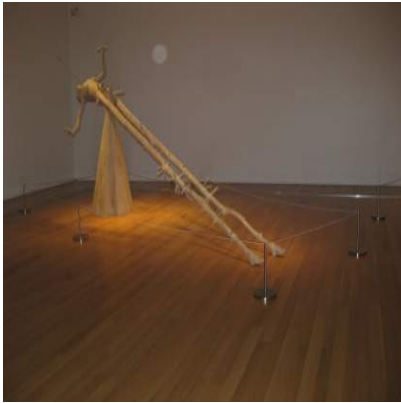
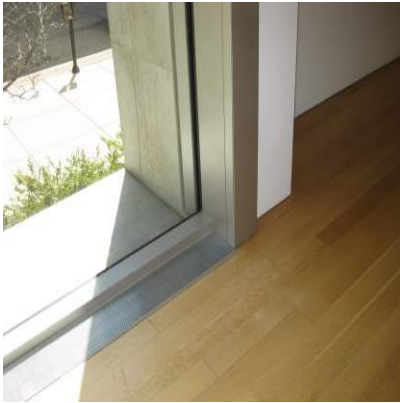
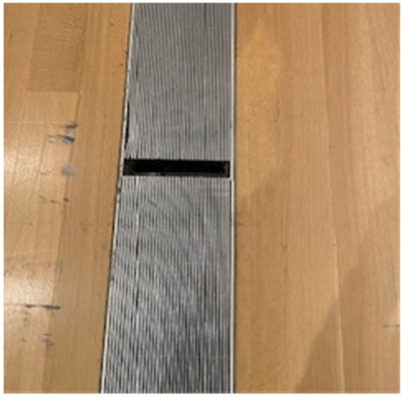
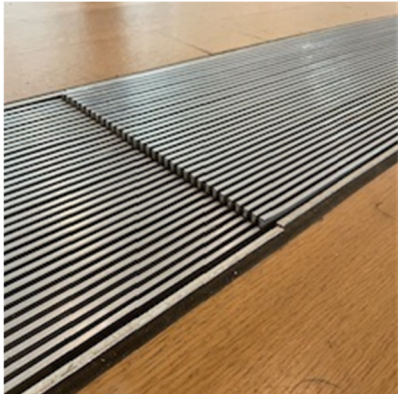
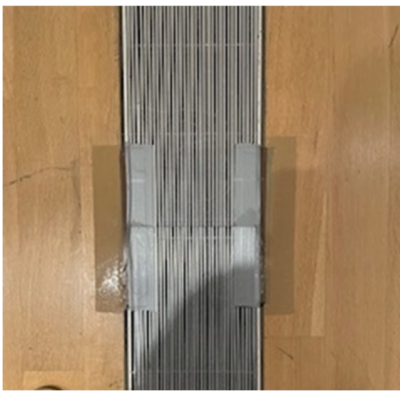
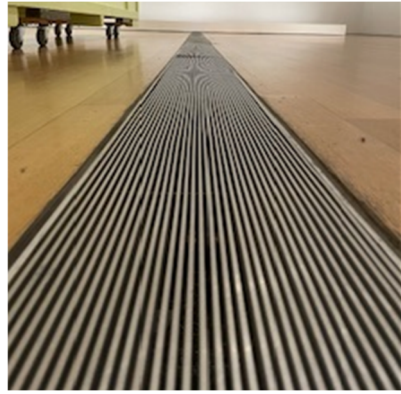
Utility Floor Grates: The utility grates, which support the building's electrical and mechanical systems, have become warped and pose tripping hazards for visitors.

Replace all floor grates.

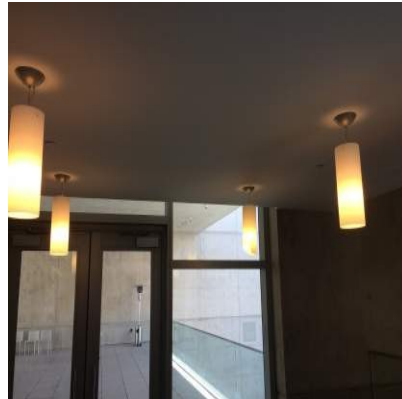
UniFormat Section: D5040.50 - Lighting Fixtures
Name: Italian Pendant Decorative Fixtures
Priority: N/A
Location: 2nd Floor Lounge/Atrium area
Manuf Type:
Today's Cost: \$50,000
Observation: There is a one fixture that has decorative glass that is broken. This is in a prominent public area.
Reason for Replacement: Broken lens
Evaluation Rating: 4 - Most functions perform
Recommendations: Replace portion of fixtures and store for attic stock for remaining.

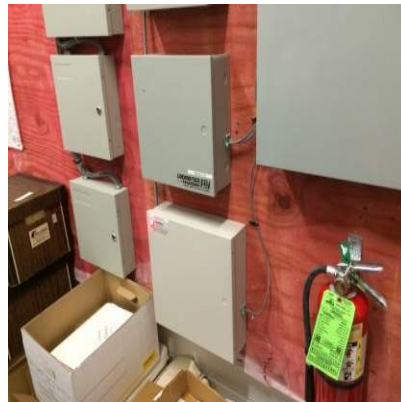
UniFormat Section: D70 - Electronic Safety and Security
Name: Video Surveillance System
Priority: Critical (6 months - 1 year)
Location: Various Locations throughout the building
Manuf Type:
Today's Cost: \$32,500
Observation: Existing system is experiencing issues and components are obsolete.
Reason for Replacement: Age / Useful Life
Evaluation Rating: 4 - Some functions do not perform
Recommendations: Recommend upgrading to new servers.

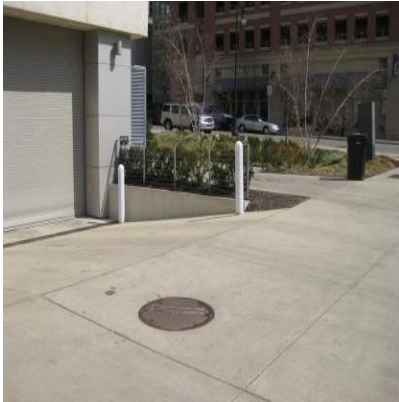
UniFormat Section: B1010.50 - Ramps
Name: Loading Dock Ramp
Priority: Moderate (1 - 5 years)
Location: Outdoor Loading dock
Manuf Type: Custom
Today's Cost: N/A
Observation: Art delivery trucks cannot use the ramp and dock due to slope issues with the street
Reason for Replacement: N/A (No replacement planned)
Evaluation Rating: 3 - Some functions do not perform
Recommendations: Modify area to function as required by facility operations.

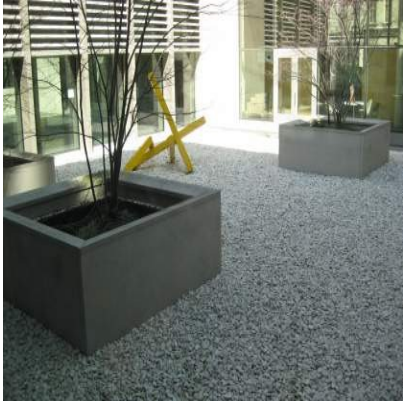
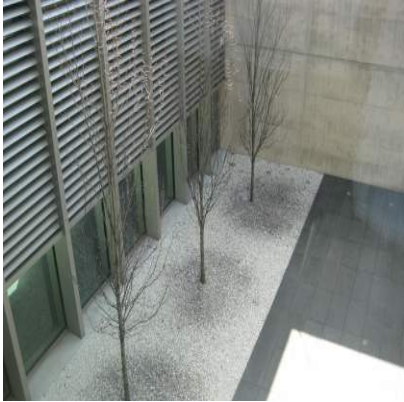
UniFormat Section: G2080.50 - Planting Accessories
Name: Planters
Priority: Critical (6 months - 1 year)
Location: Dining Court and Sculpture Court
Manuf Type: Custom
Today's Cost: \$3,500
Observation: Not observed but during conversation it was determined that there was a leak in one planter that needed to be addressed.
Reason for Replacement: Age / Useful Life
Evaluation Rating: 3 - Some functions do not perform
Recommendations: Repair
