Appropriations Requests for Legislatively Directed Spending Items

The following pages contain Plante Moran Cresa's (PMC) Facility Assessment of the Royal Oak Public Library. The assessment was based upon visual inspection of the existing building and site conditions, and interviews with library personnel. The documented Facility Report includes operational system improvements related to mechanical, electrical, plumbing, interior finishes, building envelope, and other building systems. While the assessment was not exhaustive or destructive in nature, the intent is for the report to serve as a road map for Royal Oak Public Library for future capital projects related to the facility.

Royal Oak Public Library – Building Information

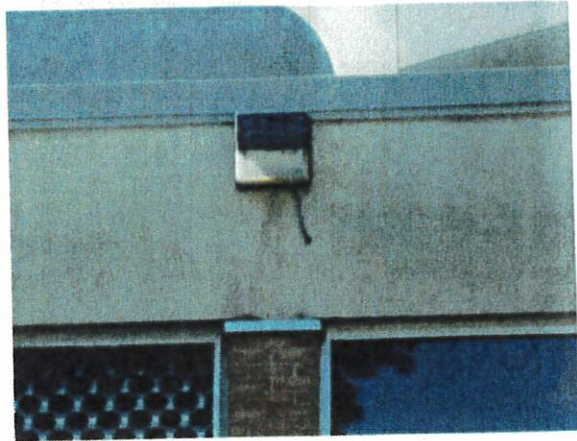
The site is illuminated by older wall and soffit mounted lighting fixtures and should be replaced with energy efficient LED fixtures. There are decorative, fluorescent pole light fixtures with discolored lenses at the south plaza which should also be updated to LED to match the pole mounted light fixtures that have been installed along the sidewalk at the north of the library.

Building Exterior – Light Packs

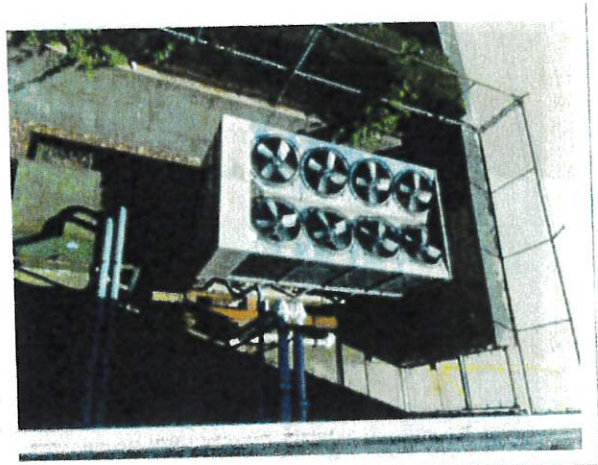
During the visit, it was noted that only two out of the eight fans on the chiller were running. It is recommended that a condition assessment be conducted by a licensed third-party contractor to evaluate the chiller for operational adequacy.

Chiller – Condensing Fans

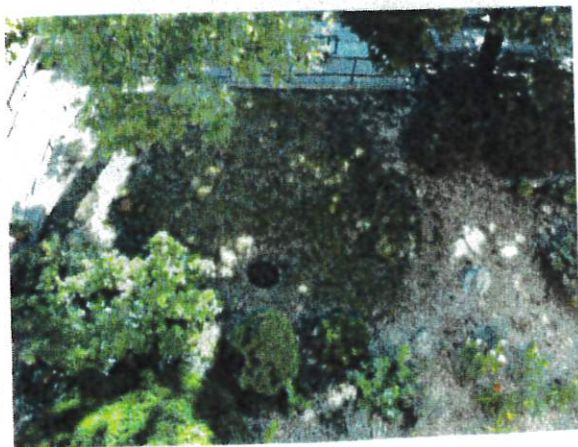
Southeast Site

The south side of the library has a large greenspace with copious plantings. There appears to be a handful of dead trees that should be removed. The stone steps and pavers appear to be in good condition with only minor attention required around the base of the trees.

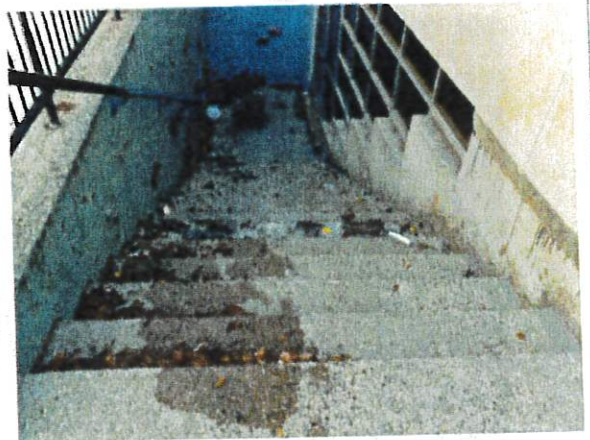
The basement level exit stair on the west side of the library has steps with spalling concrete and a raised drain at the base of the stairs creating a trip hazard. The drain cover should be replaced with a flush mount and the steps should be removed and replaced.

Exit Stairwell – West

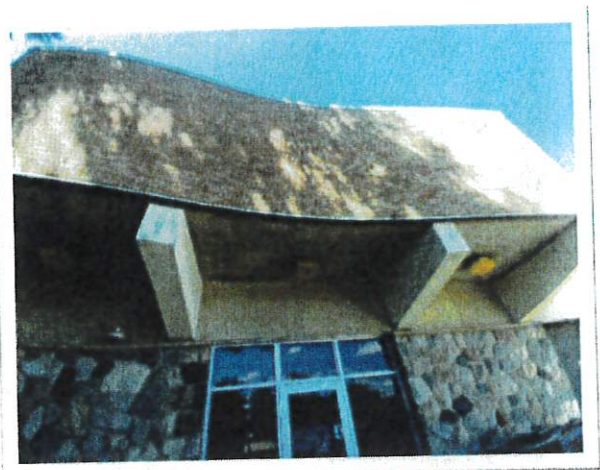
**Building Exterior – Lighting /
Peeling Paint**

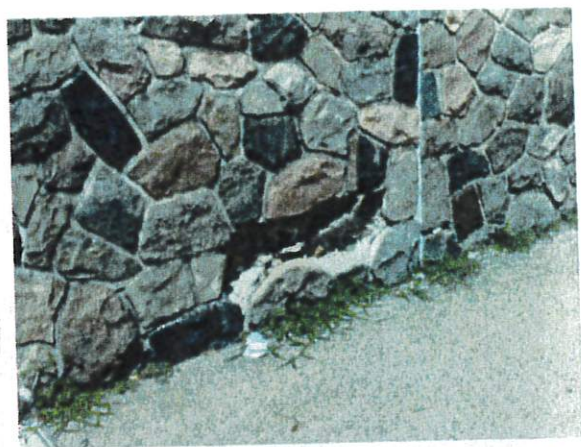
The retaining wall at the east elevated walkway has deteriorated to the point where large portions of the concrete are missing, holes through the concrete can also be seen on the top of the walkway. The entirety of this walk should be replaced. The railing should also be addressed. It is rusting, with peeling paint and a portion at the terminus is missing. The retaining wall at the condensers has areas of stone that have fallen off as well as areas of previous repair. A stone mason should be engaged to evaluate the wall and conduct the necessary repairs.

East Retaining Wall – Stone Failing

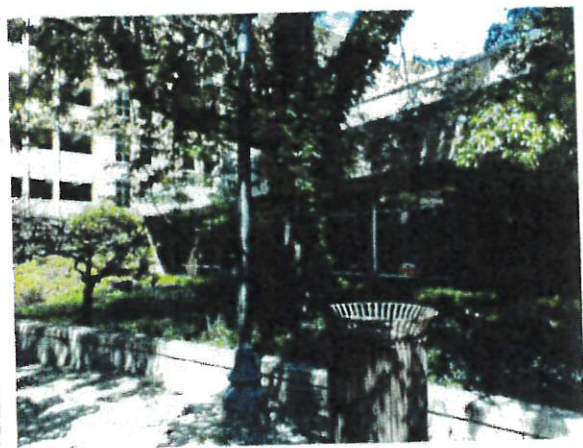
There are many plantings around the building that should be removed and replaced as they are overlarge/ hide the façade or are past their useful life.

Building Exterior – South Plantings

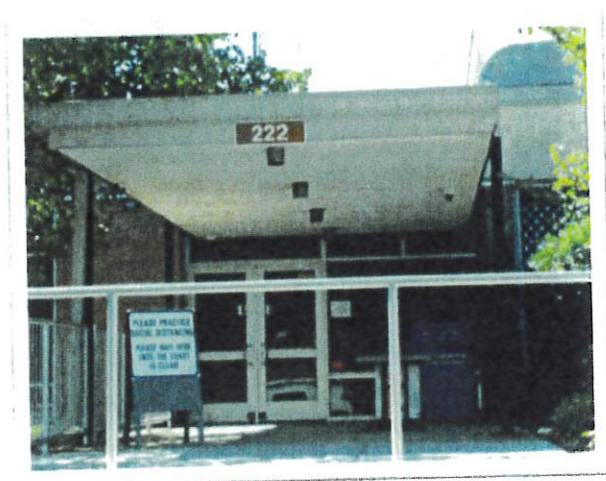
The north front canopy roof was not replaced with the 2006 renovations, and the underside fluorescent lighting is recommended for replacement. As there is no signage at the front main entry of the library, there is opportunity to remove and replace this canopy in order to provide a more welcoming entry with signage that promotes the library from the street.

Building Exterior – North Entry

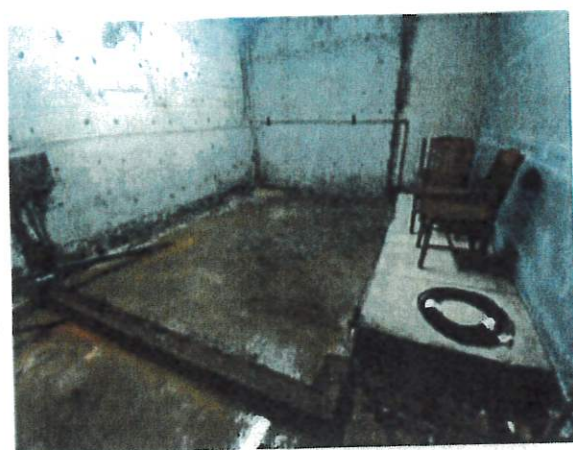
The mechanical room appears to have perimeter water infiltration and should be investigated by a licensed professional to determine the best course of correction.

Mechanical Room – Water Infiltration

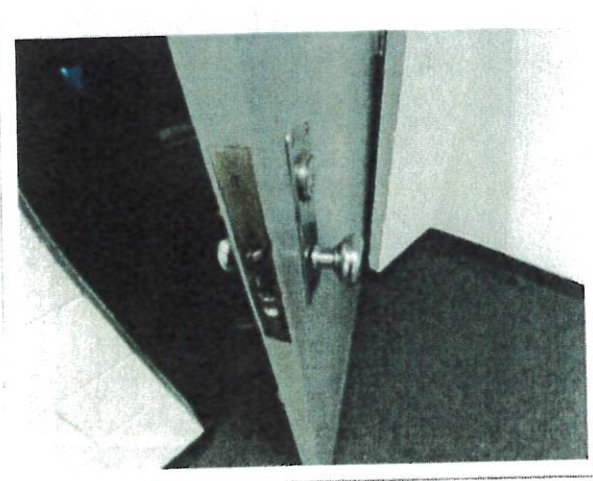
The hardware throughout the facility has been replaced with lever hardware and appears to comply with ADA 404.2.7 allowing for operation with a closed fist or loose grip that will accommodate the greatest range of users. The noted exception are the operations doors on the basement level for back of house functions. The doors themselves are in good condition but the hardware may be replaced to allow for greater access by people with disabilities.

Knob Hardware

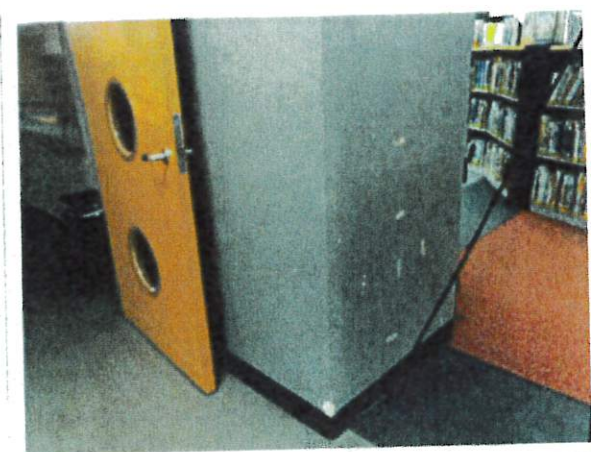
Cart Damage

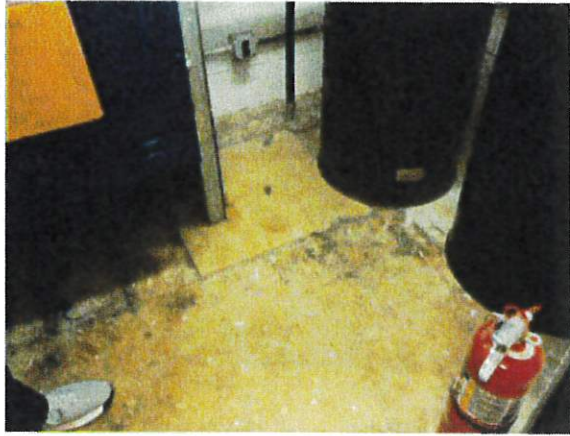
Asbestos Flooring – Elevator Room
