Appropriations Requests for Legislatively Directed Spending Items

CITY OF MADISON HEIGHTS FIRE STATION #1

31313 BRUSH STREET, MADISON HEIGHTS, MI

FIRE STATION #1

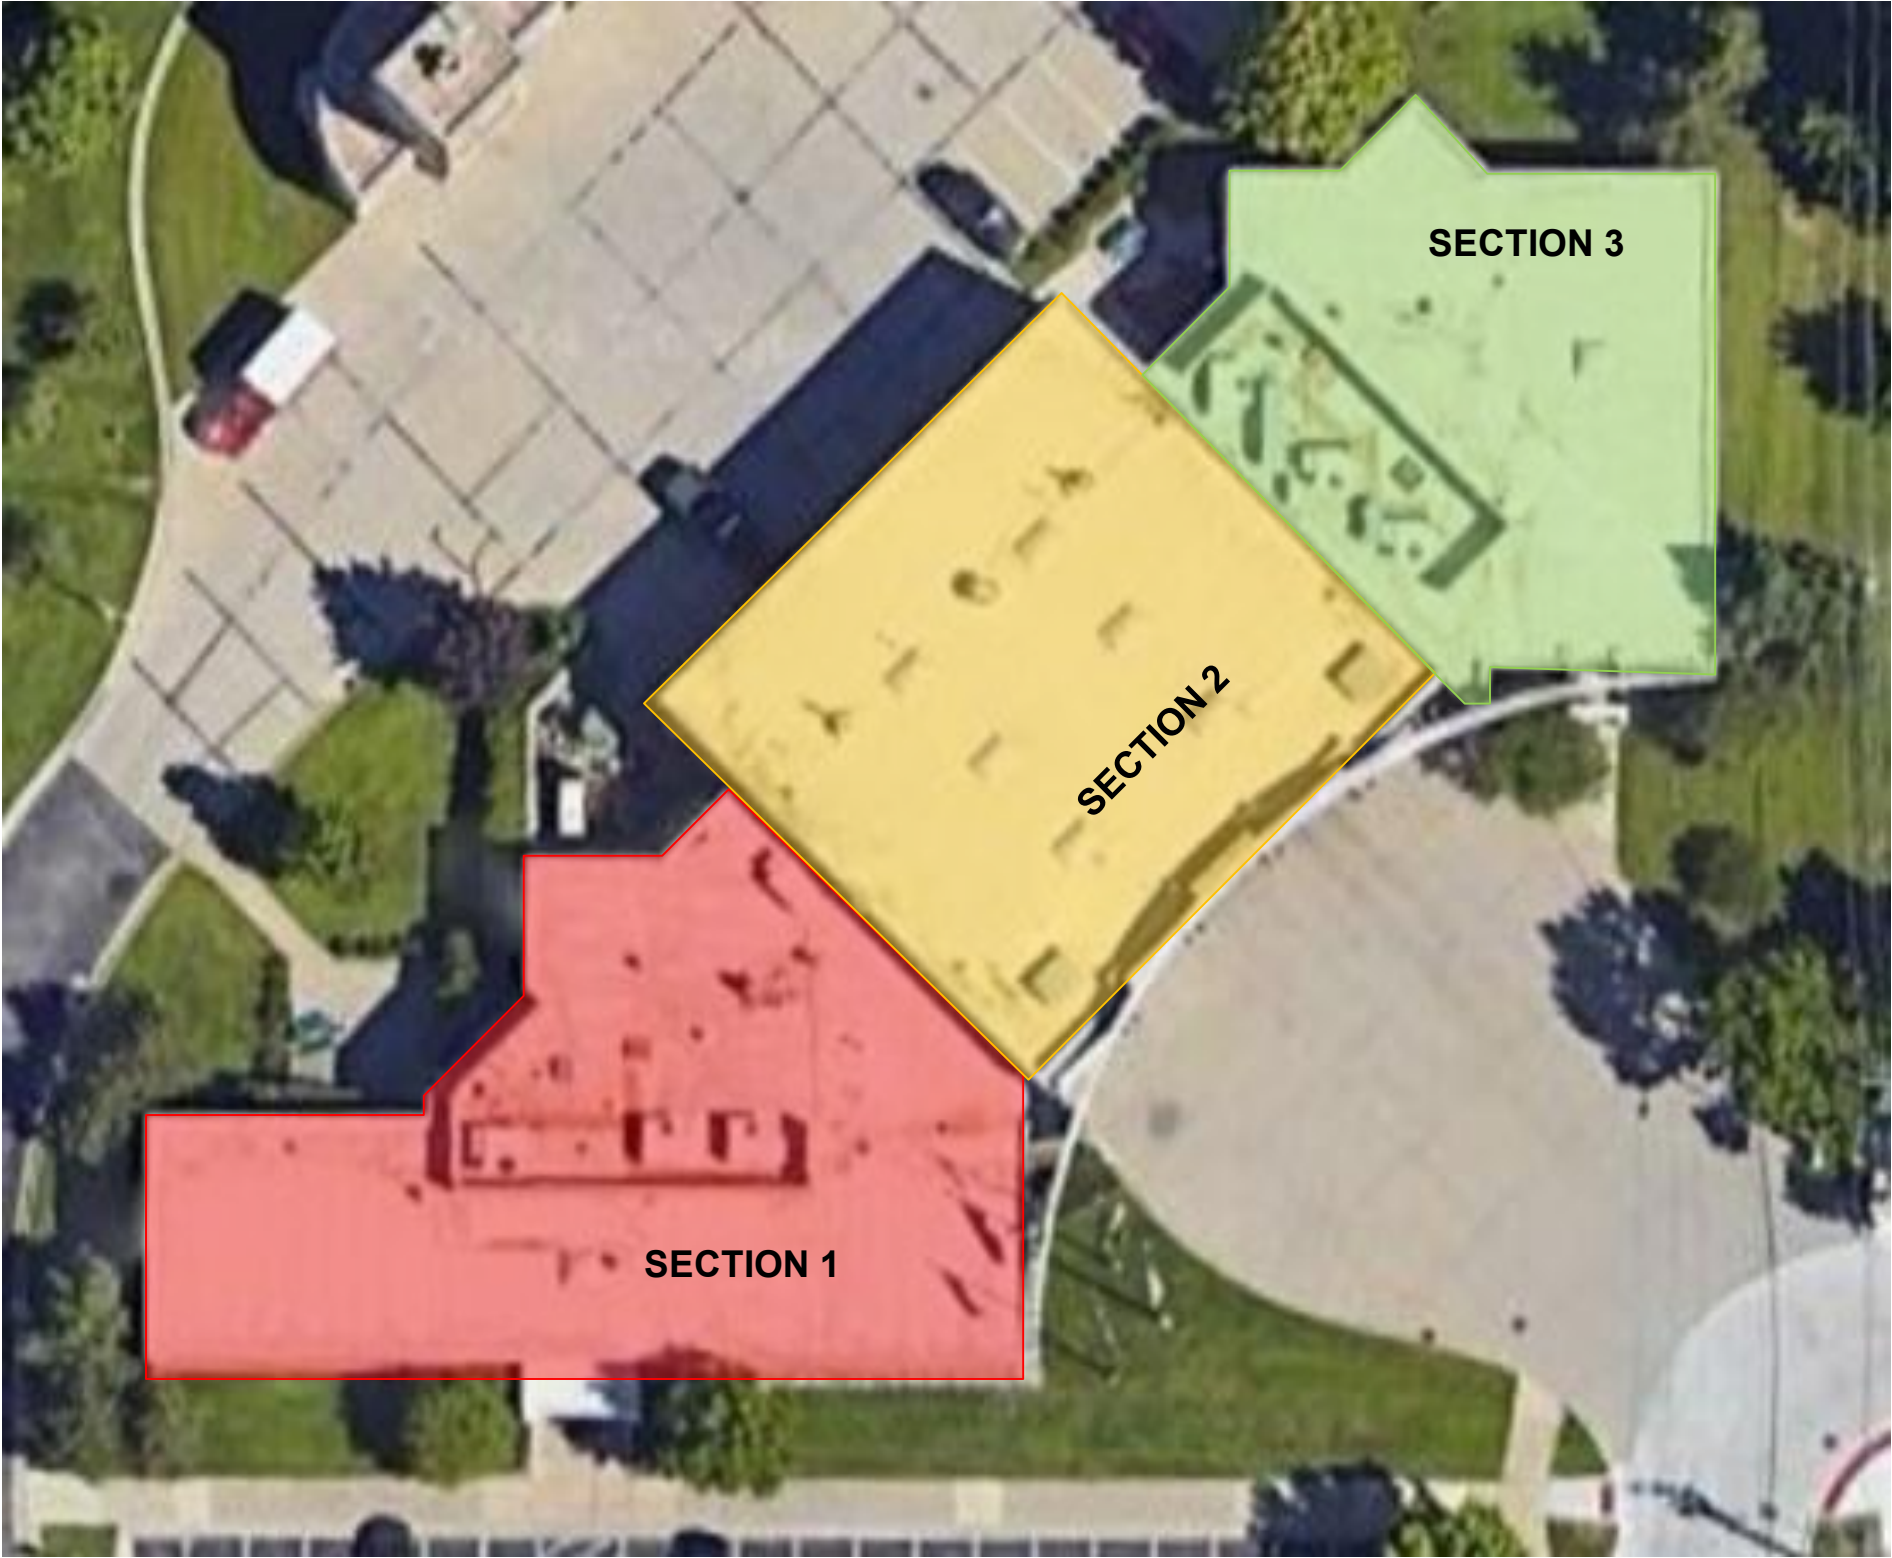
PLAN VIEW

- THREE ROOF SECTIONS ACCESSIBLE BY HATCH AND ROOFTOP LADDERS
- LEAKS WERE REPORTED IN THE BUILDING ON SECTIONS 1 & 2 HOWEVER THERE WAS EVIDENCE OF LEAKS ON SECTION 3 AS WELL

- THE ROOF IS A SINGLY-PLY, PVC ROOF SYSTEM THAT APPEARS TO BE THE ORIGINAL ROOF FOR THE BUILDING ESTIMATED TO BE 20-21 YEARS OLD
- THE ROOF SECTIONS APPEAR TO HAVE GOOD SLOPE TO THE INTERNAL DRAIN LOCATIONS WITH MINOR PONDING/COLLECTION OF DEBRIS AROUND WRINKLES WITHIN THE MEMBRANE.

- THERE IS A LIGHTNING PROTECTION SYSTEM ON THE ROOF THAT WILL NEED TO REMAIN FUNCTIONAL
- **OVERALL CONDITION:** THE SINGLE-PLY ROOF SYSTEMS TYPICALLY HAVE AN AVERAGE OF 12 YEAR LIFE-EXPECTANCY BEFORE THEY START BREAKING DOWN AND EXPERIENCE LEAKING. THIS ROOF IS NO DIFFERENT. THE MEMBRANE IS SHOWING SIGNS OF WEAR AND FAILURES/SPIRALING CAN BE SEEN THROUGHOUT ALL SECTIONS OF THE MEMBRANE. THE ROOF HAS EXCEEDED ITS LIFE-EXPECTANCY AND UNFORTUNATELY, RESTORATION IS NOT AN OPTION FOR PVC MATERIALS DUE TO CLEANING AND ADHESION ISSUES. REPLACEMENT IS THE LIKELY OPTION.

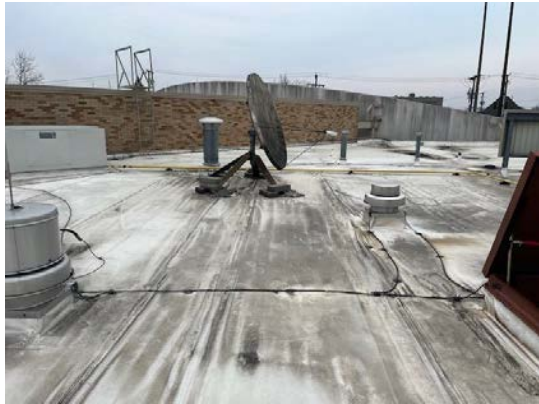
OVERALL VIEW OF THE ROOF ON SECTION 1. IT APPEARS AS THOUGH THERE ARE SOME ABANDONED ITEMS ON THE ROOF THAT CAN BE REMOVED.

THE ROOF IS A SINGLE-PLY, PVC MEMBRANE. OVER TIME, THE MEMBRANE BECOMES BRITTLE AND THE TOP LAYER OF THE 45 MIL MEMBRANE WEARS, EXPOSING THE REINFORCING SCRIM

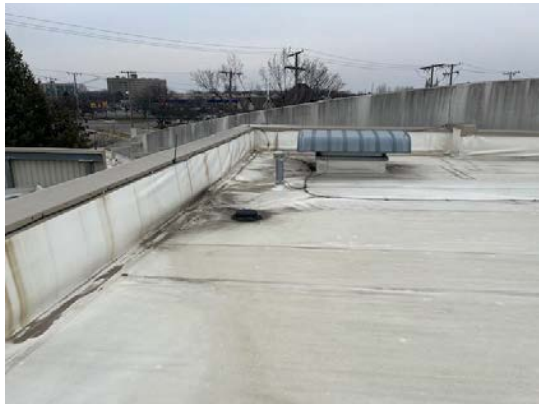
BECAUSE THE MEMBRANE CONTAINS 'FILLER' MATERIALS, AS THE FACE OF THE MEMBRANE WEARS, IT'S NOT UNUSUAL TO SEE ORGANIC GROWTH LATCHING ON TO THOSE FILLERS IN THE MEMBRANE.

BECAUSE THE MEMBRANE IS MECHANICALLY ATTACHED, THERE ARE WRINKLES THROUGHOUT.

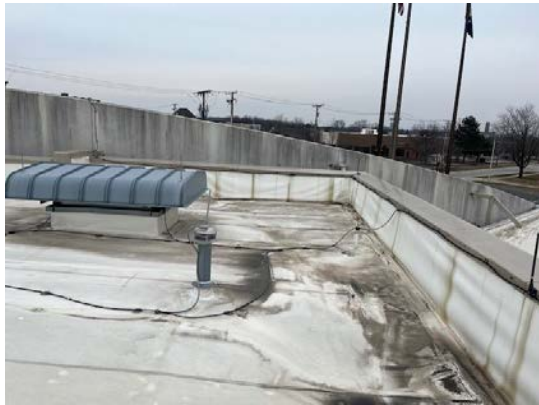
THOSE WRINKLED AREAS TEND TO HOLD WATER, ACCELERATING THE DETERIORATION OF THE MEMBRANE. WITH THE ROOF BEING OVER 20 YEARS OLD, THE ROOF MEMBRANE IS BEYOND ITS SERVICABLE LIFE. SINGLE PLY SYSTEMS TYPICALLY HAVE A 12-15 YEAR LIFE EXPECTANCY BEFORE THEY BEGIN LEAKING.

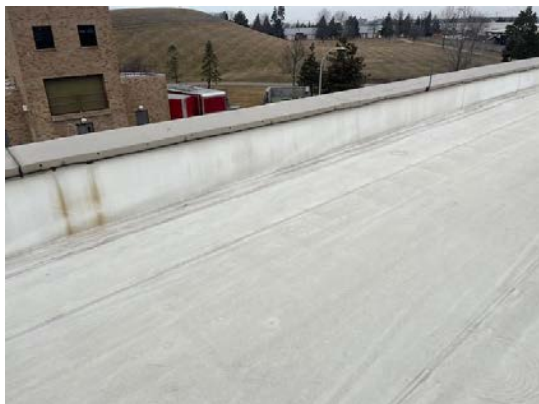
WITH THIS SINGLE-PLY MEMBRANE BEING COMPRISED OF PVC, IT DOES NOT LEND ITSELF TO BEING CLEANED EFFECTIVELY AND THEREFORE DOES NOT HAVE A HIGH SUCCESS RATE FOR RESTORING THE ROOF WITH A COATING.

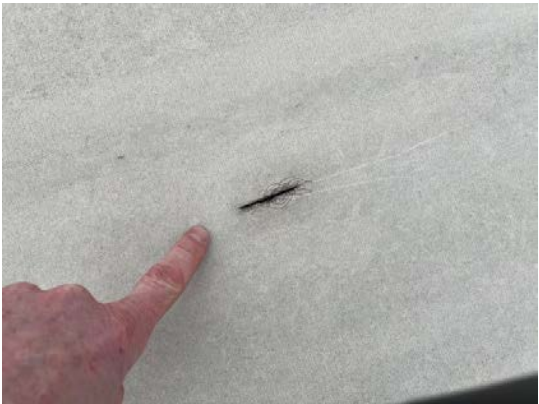
WITH THE ROOF BEING A SINGLE-PLY SYSTEM, IT IS EASY TO PUNCTURE THE ROOF WITH ANYTHING FROM A LOOSE SCREW FROM A MECHANICAL UNIT TO A DROPPED TOOL WHILE SERVICING A UNIT ON THE ROOF. THIS PUNCTURES APPEARS AS THOUGH SOMETHING SKID ACROSS THE ROOF IN A WIND EVENT.

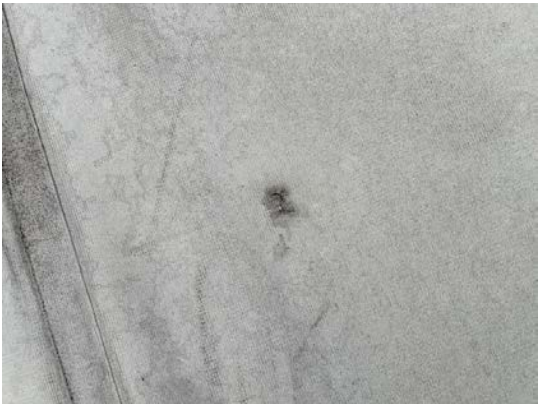
THERE ARE SMALL PUNCTURES AS WELL AS "SPRIALS" THROUGHOUT THE ROOF. SPIRAL FRACTURES ARE CAUSED BY THE MEMBRANE BECOMING BRITTLE AS IT AGES AND GETS COLD. POINT LOADS SUCH AS HAIL, ICE, AND FOREIGN OBJECTS ALL CAUSE THESE SPIRALS, WHICH IS ESSENTIALLY THE MEMBRANE CRACKING.

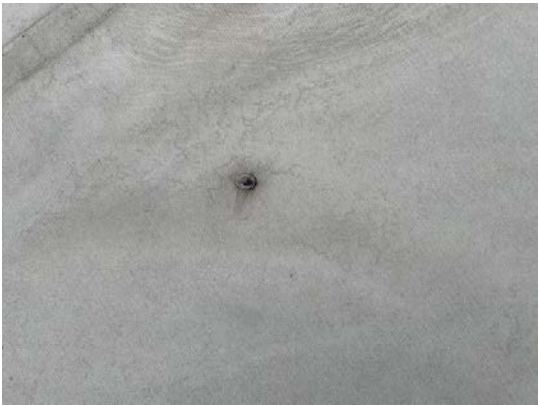
THE SPIRAL FRACTURES ARE PREVALENT THROUGHOUT THE ROOF. WHILE MANY OF THE LEAKS MAY NOT BE SIGNIFICANT, IT IS A SURE SIGN THAT THE ROOF HAS REACHED THE END OF ITS LIFE. THE ROOF WILL CONTINUE TO BECOME MORE BRITTLE AND CAUSE SIGNIFICANT ISSUES AS IT AGES.

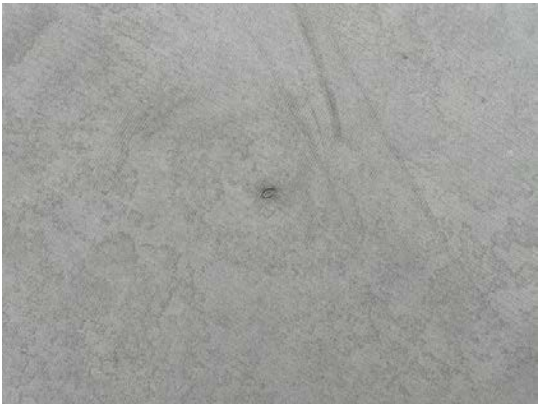
LEAK AREA REPORTED ABOVE THE OFFICES NEAR THE MAIN ENTRANCE.

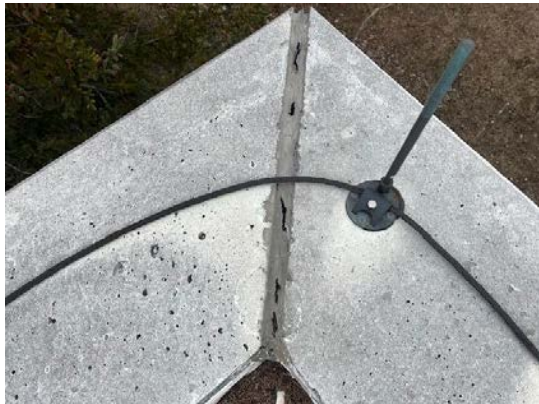
THE STONE COPING CAPS ARE SEALED WITH SEALANT. IT IS EVIDENT THAT MOISTURE IS GETTING INTO THE WALL ASSEMBLY AS WELL, NOT NECESSARILY PRESENTING AS A LEAK CONDITION BUT CREATING THE POSSIBILITY OF SPAWLING AS WELL AS EFFLORESCENCE WITHIN THE MASONRY SYSTEM (CREATING MINERAL DEPOSITS ON THE EXTERIOR OF THE WALLS)

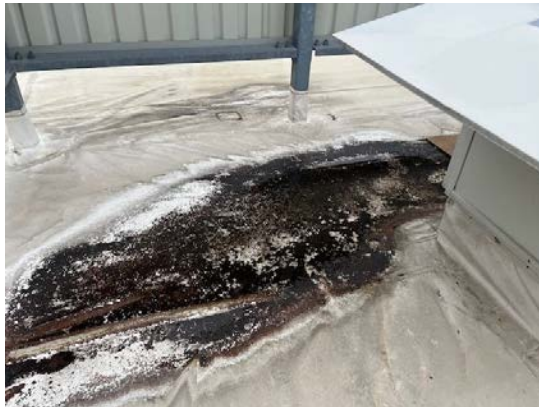
BECAUSE THE SINGLE-PLY PVC MEMBRANE CONTAINS FILLER MATERIALS, THE MEMBRANE IS SUBJECT TO MOLD GROWTH IN AREAS THAT ALLOW PONDING WATER. UNFORTUNATELY, THIS CAN OCCUR AT THE BASE OF MECHANIC UNITS AND AROUND CLEAN AIR INTAKES.

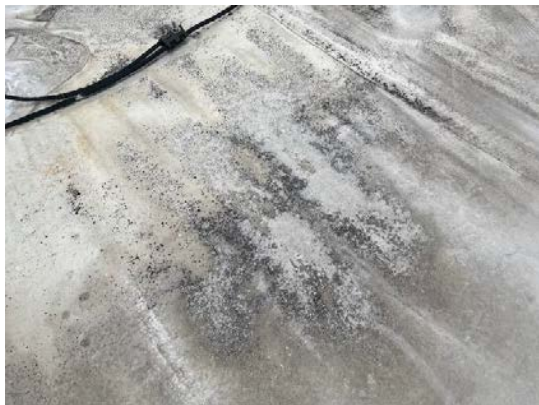
THE MEMBRANE IS SHOWING SIGNS OF WEAR AND DETRIORATION IN THE AREA ABOVE THE SCRIM.

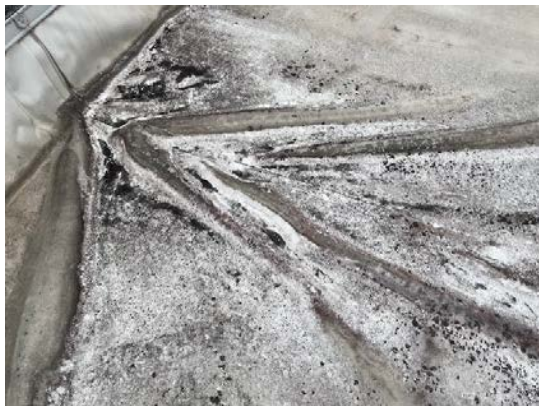
WE CAN SEE HOW THE WRINKLES IN THE MEMBRANE ENCOURAGE MOLD GROWTH ON THE ROOF BY HOLDING POCKETS OF WATER.

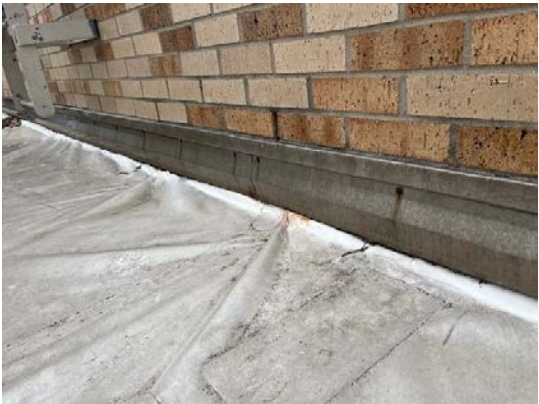
THE FLASHING AT THE BASE OF THE MASONRY WALL IS LOOSE IN SOME AREAS.

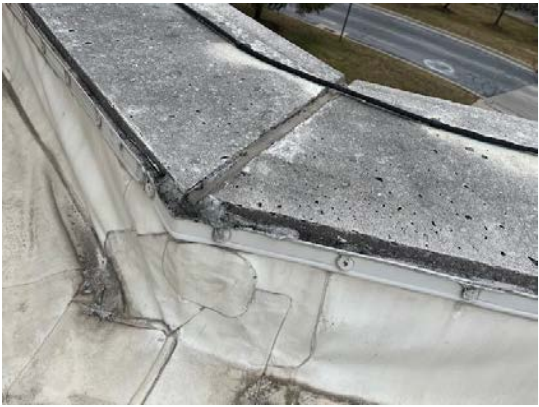
THIS IS THE TERMINATION DETAIL AROUND THE PERIMETER OF THE BUILDING. THE MEMBRANE IS TERMINATED BY A PRESSURE BAR, FASTENED TO THE BACK OF THE MASONRY CAP ABOUT EVERY 6"-8" AND THEN CAULKED. ESSENTIALLY, THE WATERPROOFING CAPABILITIES OF THE ROOF RELY ON A SINGLE CAULK JOINT. TYPICALLY, WE REQUIRE THAT THOSE HORIZONTAL TERMINATIONS BE FULLY ENCAPSULATED WITH MASTIC AND THEN FINISHED WITH A METAL COUNTERFLASHING TO KEEP THE ELEMENTS OFF OF THAT TRANSITION. THIS IS SIMPLY A BAD DETAIL

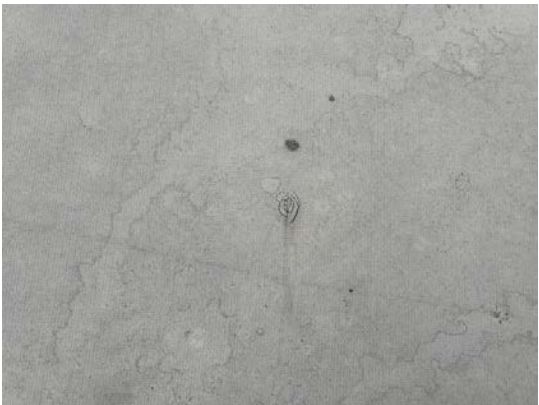
A GOOD EXAMPLE OF THE SPIRAL CRACKING AS A RESULT OF THE ROOF BEING BRITTLE.
