Appropriations Requests for Legislatively Directed Spending Items

6. If there is not a specific recipient, the intended location of the project or activity:
City of Ishpeming's Fire Tower
7. Name of the representative and the district number where the legislatively directed spending item is located:
Karl Bohnak - 109th District

PURPOSE

U.P. Engineers and Architects, Inc. (UPEA) was retained by the city of Ishpeming to perform a structural evaluation of the city's fire station tower. UPEA performed the inspection on August 19, 2024. The exterior of the tower was inspected from a boom truck operated by a member of the fire department. Also, from the roof of the buildings adjacent to the tower. The interior of the tower was visually inspected from the ground floor level. The tower was built in 1912 as part of the original fire station. In 2001, the upper 22-foot section of the tower was demolished and rebuilt to match the original. The tower holds significant historical value to the city. In addition, the lower half of it is used as a place to hang fire hoses to dry.

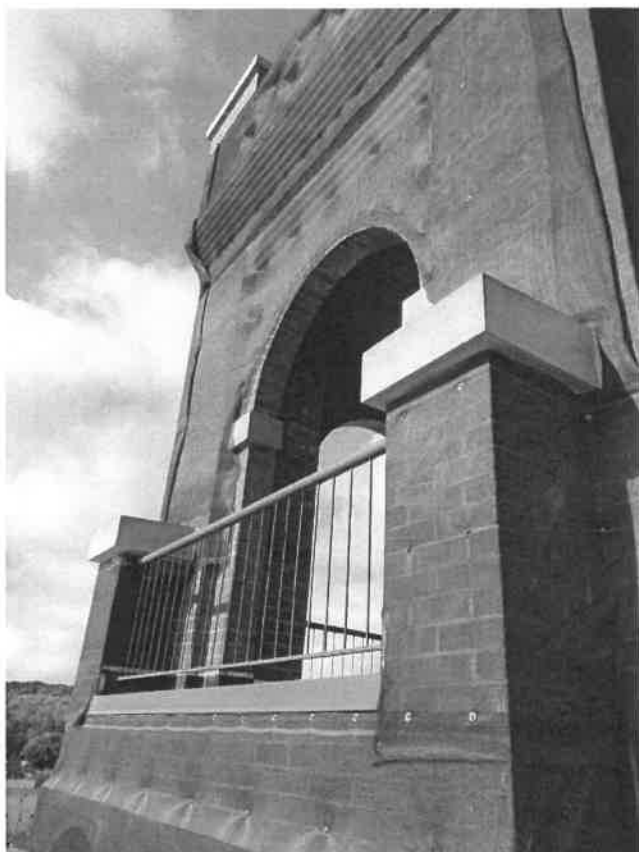
6. 2001 Addition, Fire Tower.

The upper rebuilt portion of the tower shows significant deterioration in the forms of brick spalling, cracking, and efflorescence. This may have been caused by a variety of issues, the most likely being that the brick is made of a poor-quality material or was constructed poorly. This brick deterioration will continue and eventually the upper portion of the tower will be at risk of collapse. The condition of this part of the tower is such that rehabilitation is not an option.

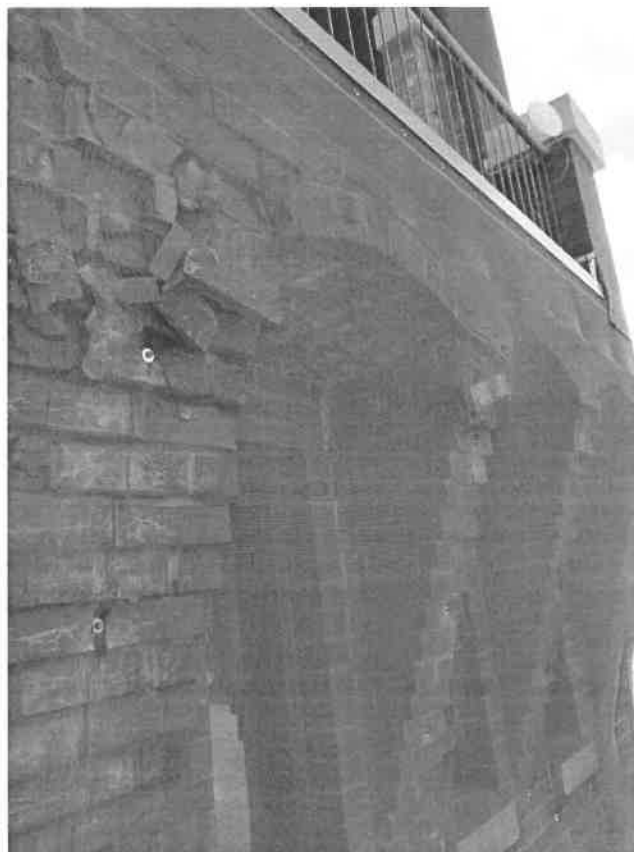
7. View of cracked and spalled brick.

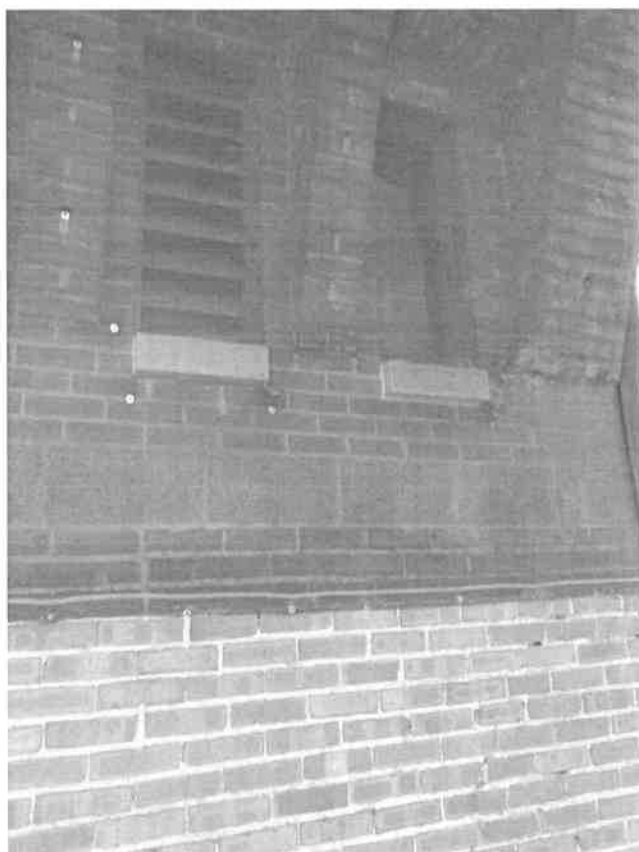
8. View of cracked and spalled brick.

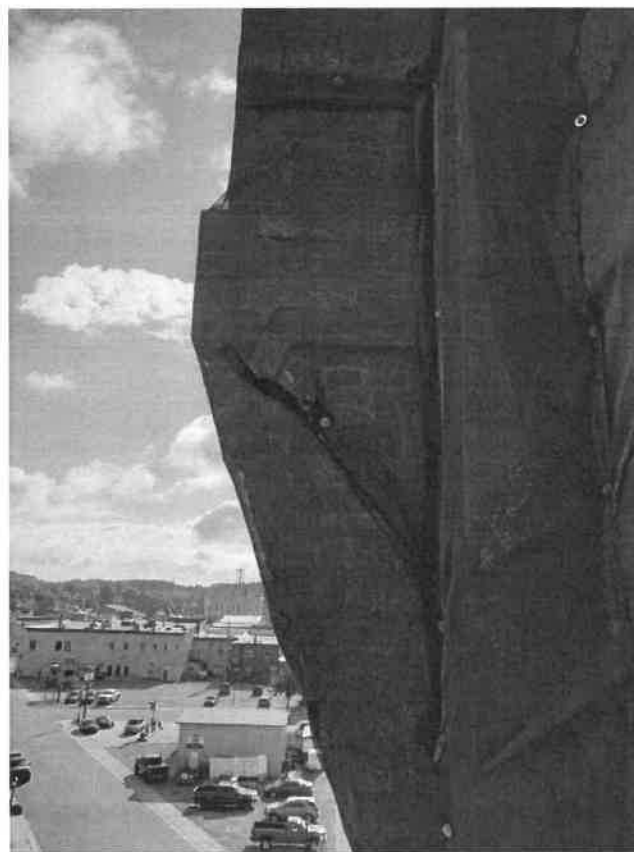
9. View of cracked and spalled brick.

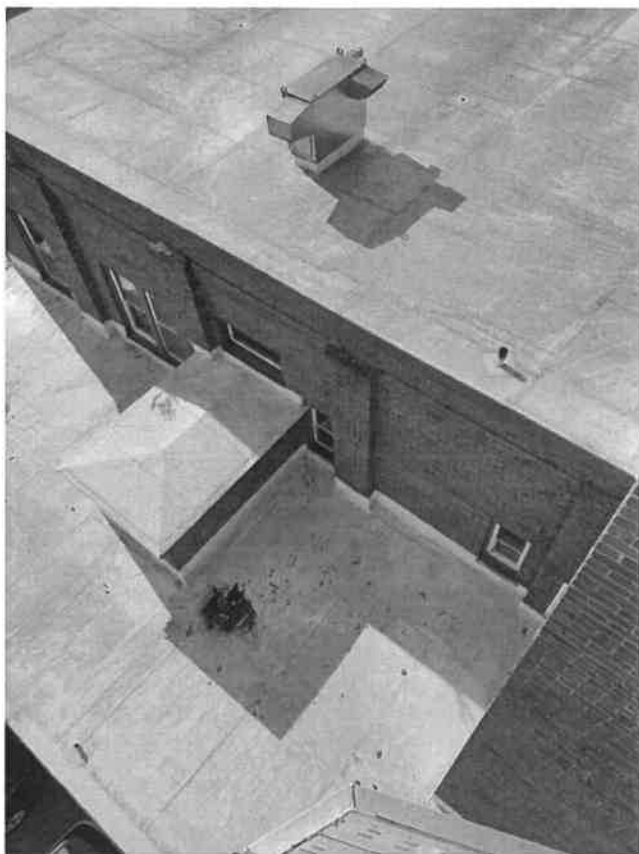
In recent years, the brick masonry of the rebuilt portion of the tower has begun splitting, cracking, and spalling. Large pieces of brick, some of them up to 7 ½ inches long by 1 inch thick, have fallen from the tower. This falling debris has the potential to damage the building and parked municipal vehicles below, as well as endanger any people near the tower.

At the recommendation of GEI Consultants, the city wrapped the upper portion of the tower with safety netting to prevent pieces of brick from falling in 2017 as a temporary safety measure. When UPEA inspected the tower, the netting was holding many pieces of brick of various sizes. The roof of the building below also was littered with brick pieces which may have escaped the safety netting. The presence of the brick debris in the netting show that the tower is continuing to deteriorate. Action should be taken as soon as possible to alleviate the risk presented by the tower while it is still in stable condition.

10. View of debris on roof below.

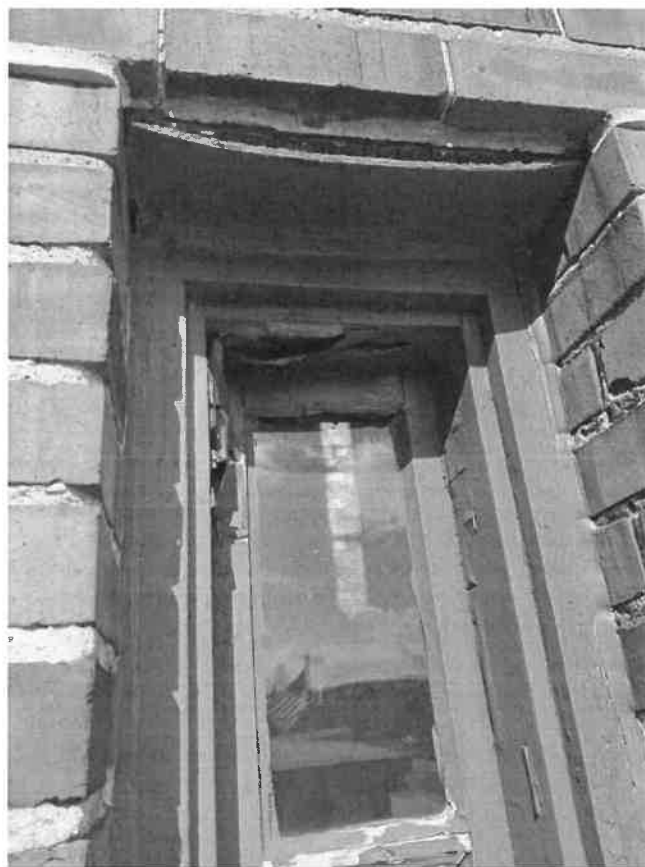
The lower part of the tower, which is original to the building, has only minor cracking and mortar loss. There are “stair-step” cracks over most of the window openings. This is caused by the expansion of the steel lintels as they rust, but it does not pose a risk to the tower’s overall stability. These issues should be addressed as general maintenance of the building.

11. Window showing swelled header.

In summary, during the inspection on August 19, 2024, UPEA found that the lower part of the tower, built in 1912, was in generally sound condition. Some maintenance issues should be addressed, such as tuck-pointing the joints, sealing against water infiltration, and painting of the steel lintels. The upper part of the tower, which was rebuilt in 2001, was in poor condition. The deterioration has continued since it was last inspected by GEI Consultants in April of 2022. While it is not in immediate danger of collapse, action should be taken as soon as possible while the structure still poses only a relatively small risk to the surrounding people and property.

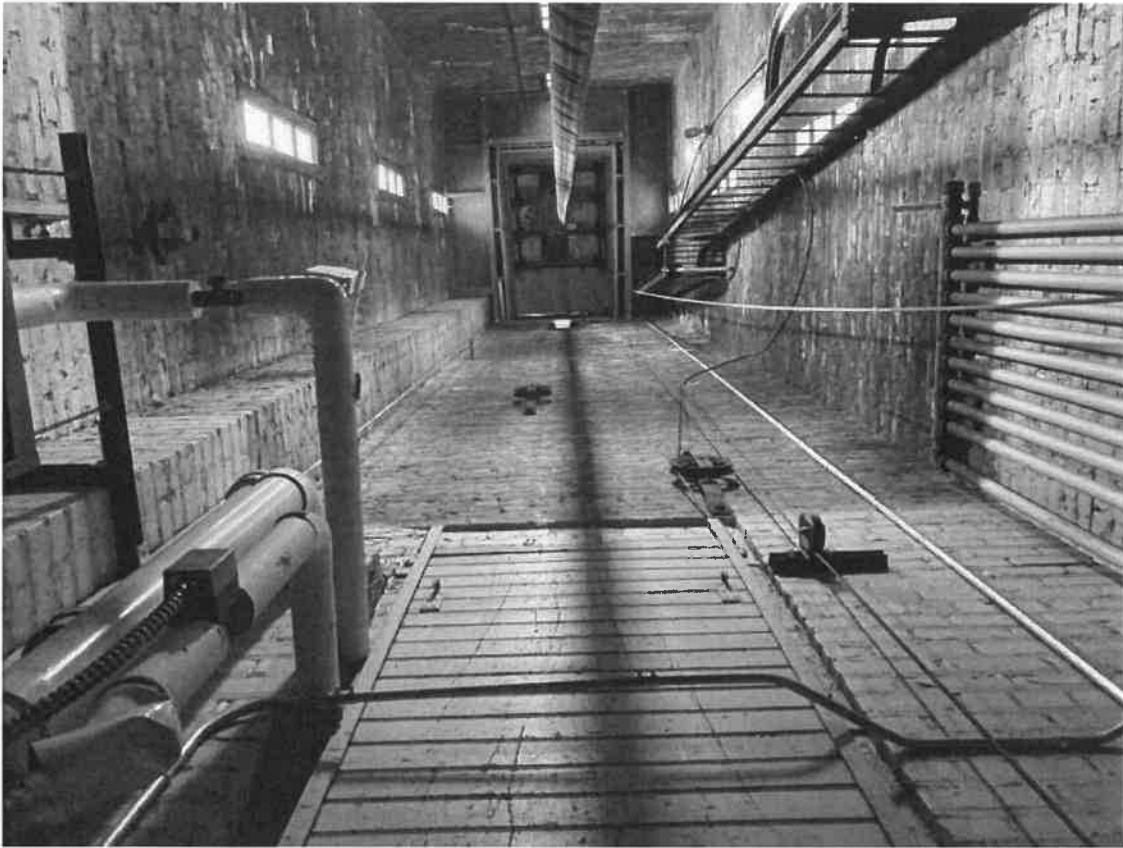
17. Interior of tower.

The inside of the tower was dry, but there was some indication of water infiltration on the ceiling. There was cracking of mortar joints and efflorescence in the brickwork of the tower.

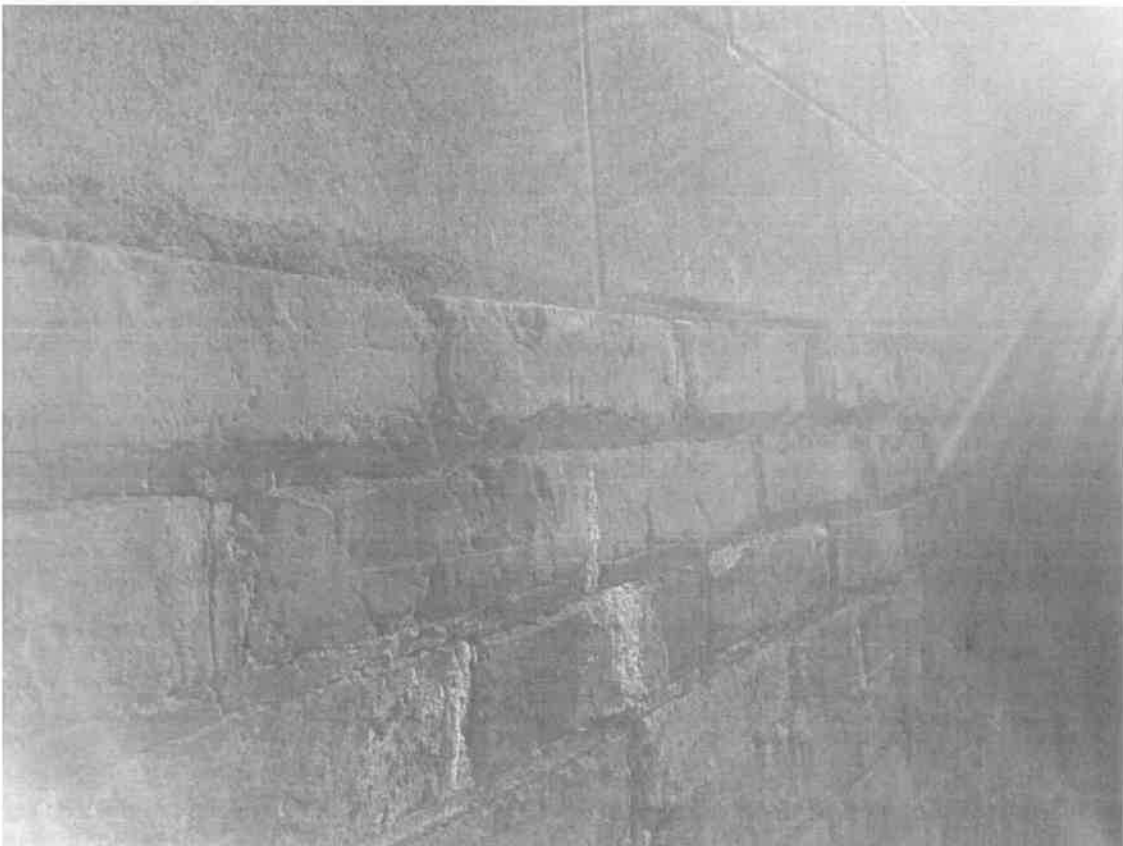
18. Condition of brick on interior, original tower (efflorescence).
