Appropriations Requests for Legislatively Directed Spending Items

Algonquin Dr over Woodland Lagoon STR 7

Bridge Inspection Report

August 2022 SGI Project No. 132341SG2022

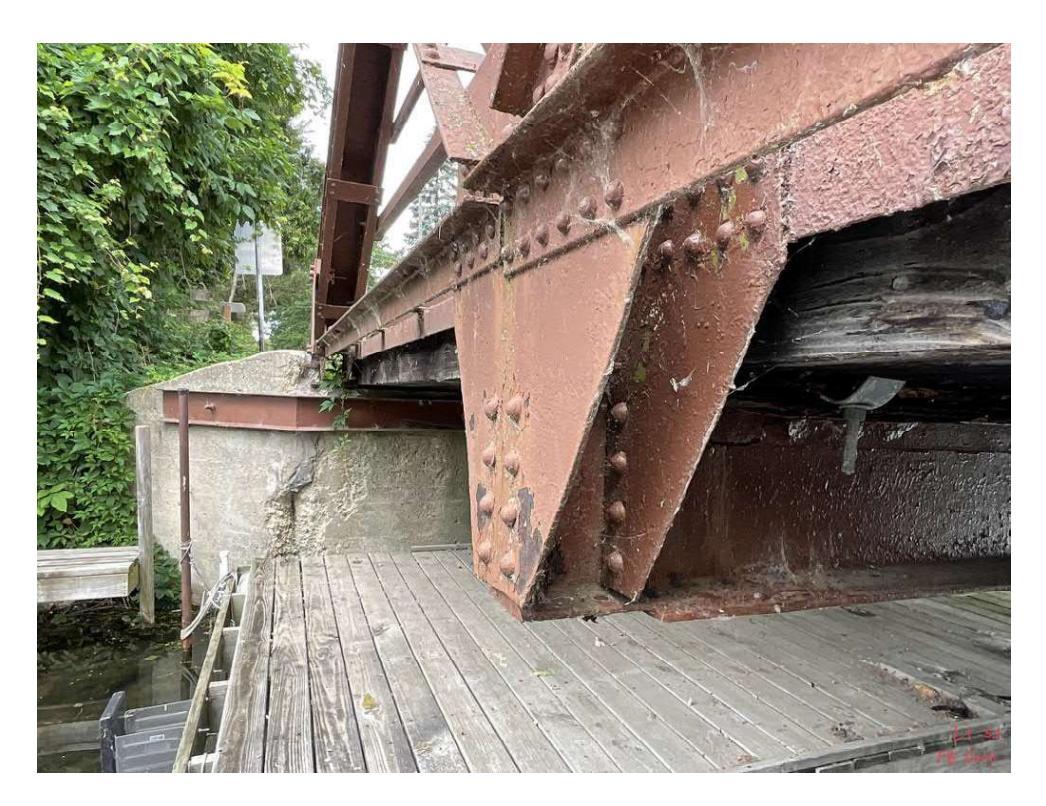
The floor-beams are in serious condition based on the section loss at the connection to the truss. There is some pack rust on the longitudinal stiffeners with minor loss of section to the rolled section. The paint is also peeling, suggesting the surface was not properly prepped when previously painted.

Name: IMG_0096 (1024x767) Description: L1 south side floor beam connection

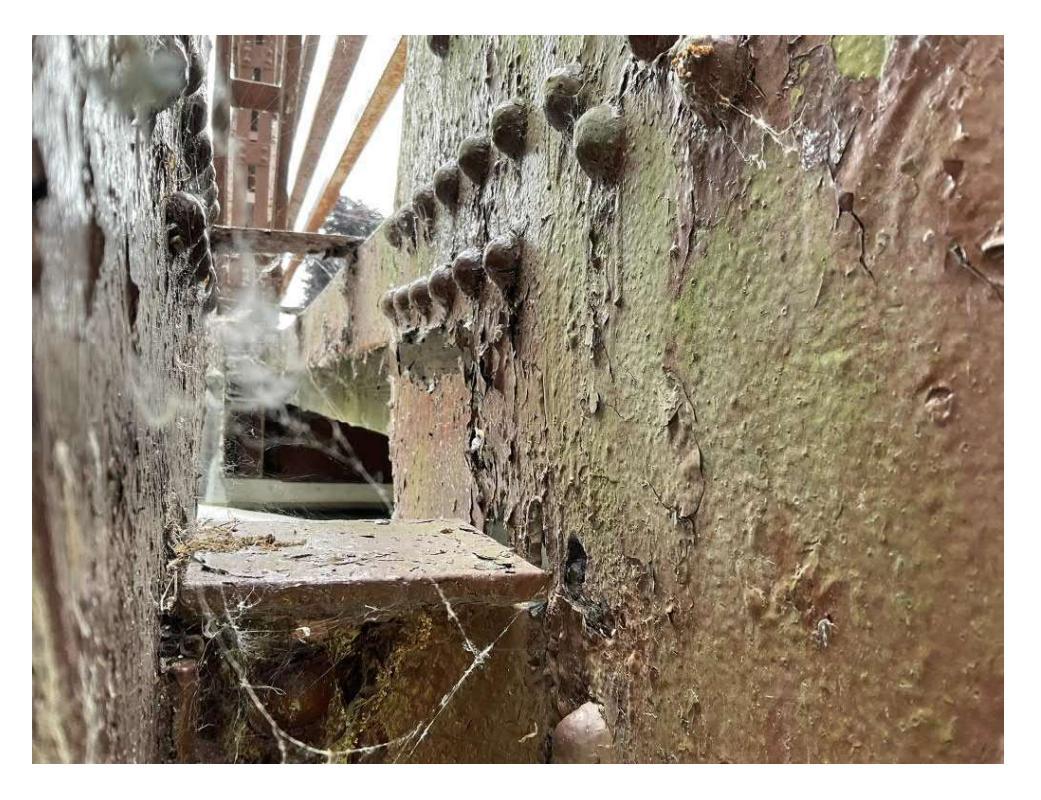
The upper gussets are in good condition with minor paint peeling at the corners. The lower gussets are in serious condition with distortion from moment being transferred through a single plate and holes through the gusset plates at all bearings and panel point L1 on the north side.

Name: IMG_0106 (1024x768) Description: L1 North side, hole

- Steel Repairs (Requires engineering design and plans)
 - o Bolt/weld steel plates to gussets with heavy deterioration
 - o Grind/punch out rivets and replace with bolts on repaired plates and members
 - Cut and weld built-up c-channel to lap gap in truss channel
 - Weld plates to lap holes in angles
- Seal or Replace Hot Mix Asphalt
 - Seal block cracking in surface and end joints
 - o or scarify hot mix asphalt and place thin, composite deck (Requires engineering design and plans)
- Railing Repair
 - Secure loose fasteners
 - Replace segments with collision damage
- Timber Repair
 - Inject epoxy/wood glue into fascia beam with shake
- Paint
 - o Blast and paint full steel structure
- Approach
 - Replace 5' of both approaches

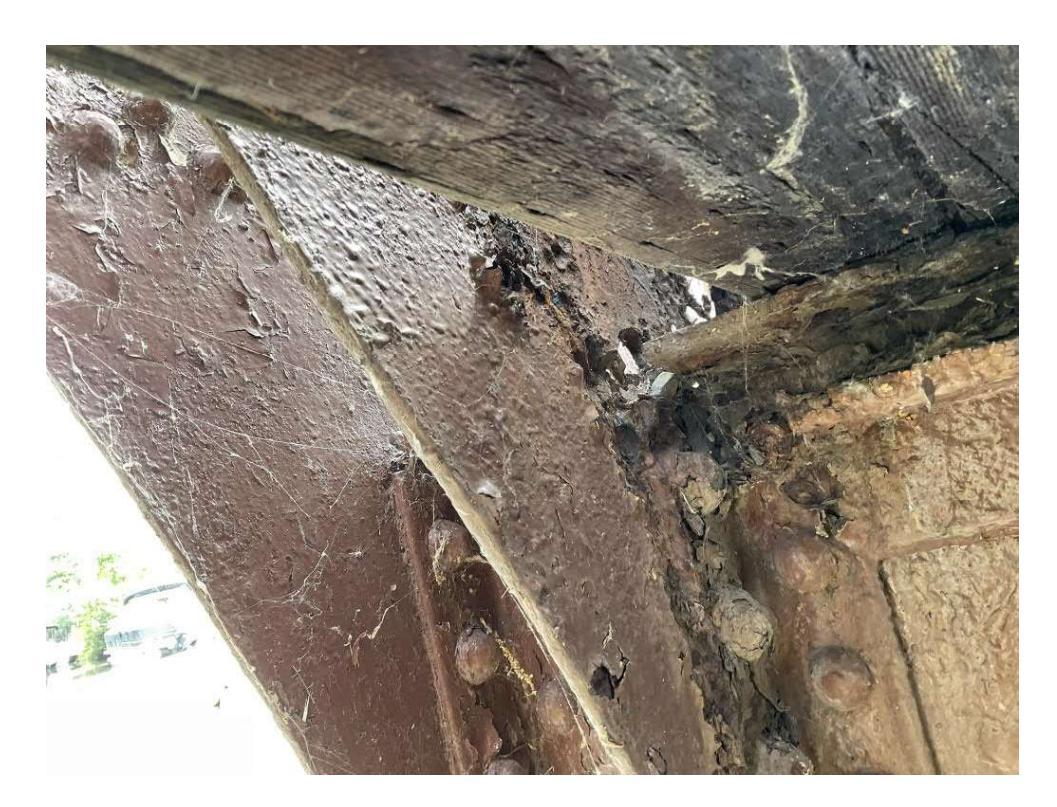
Name: IMG_0107 (1024x768) Description: L1 North side, hole

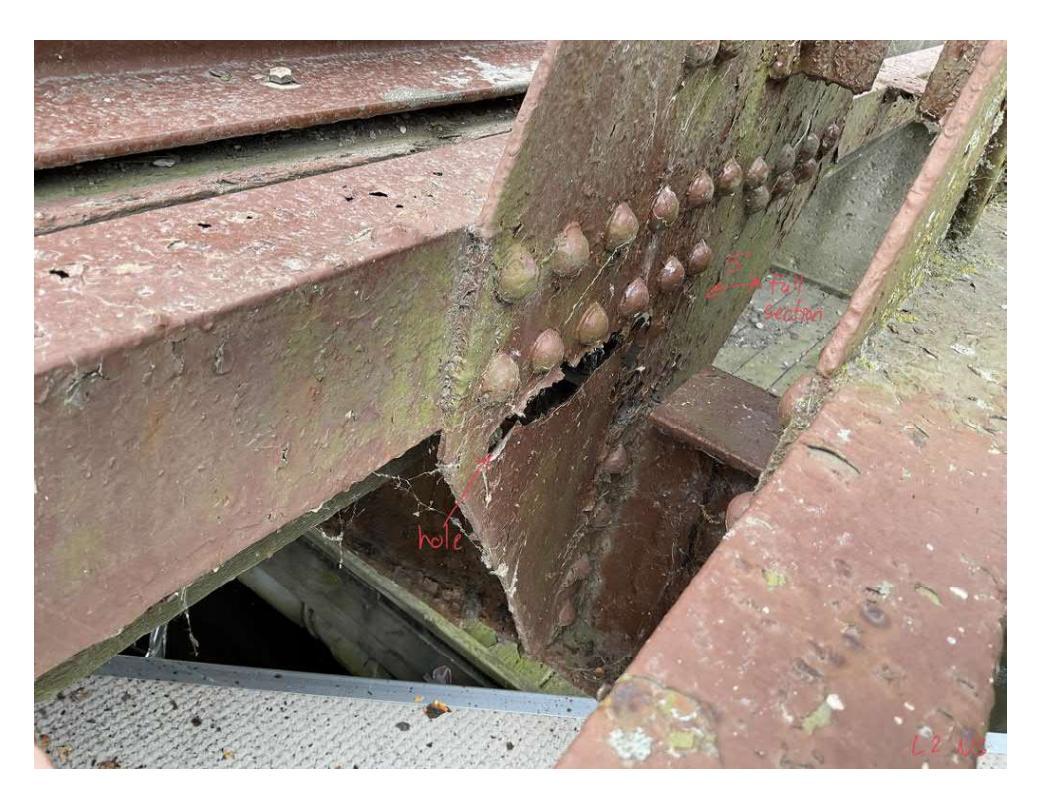
Name: IMG_0108 (1024x767) Description: L1 north side, hole

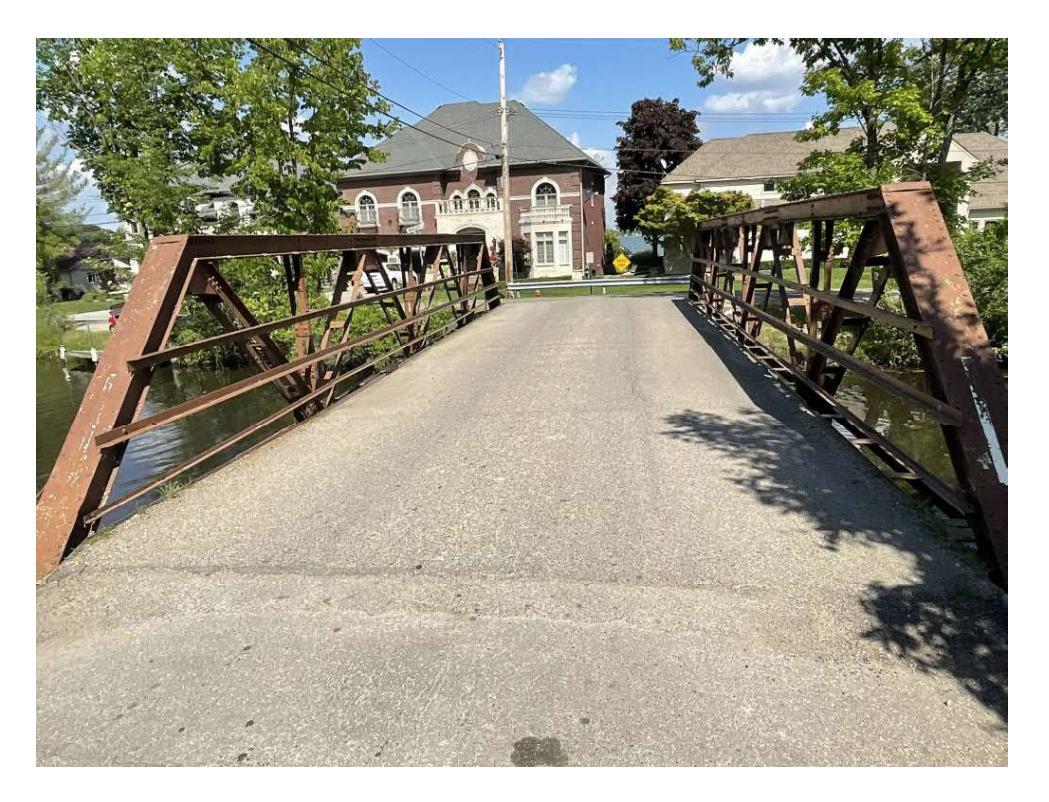
The deck surface is not visible and is based on the hot mix asphalt overlay surface. In general, the surface is in fair condition. There is block cracking approximately every 10' in-line with the floor beams and centerline of the roadway.

Name: IMG_0203 (1024x768) Description: Deck surface

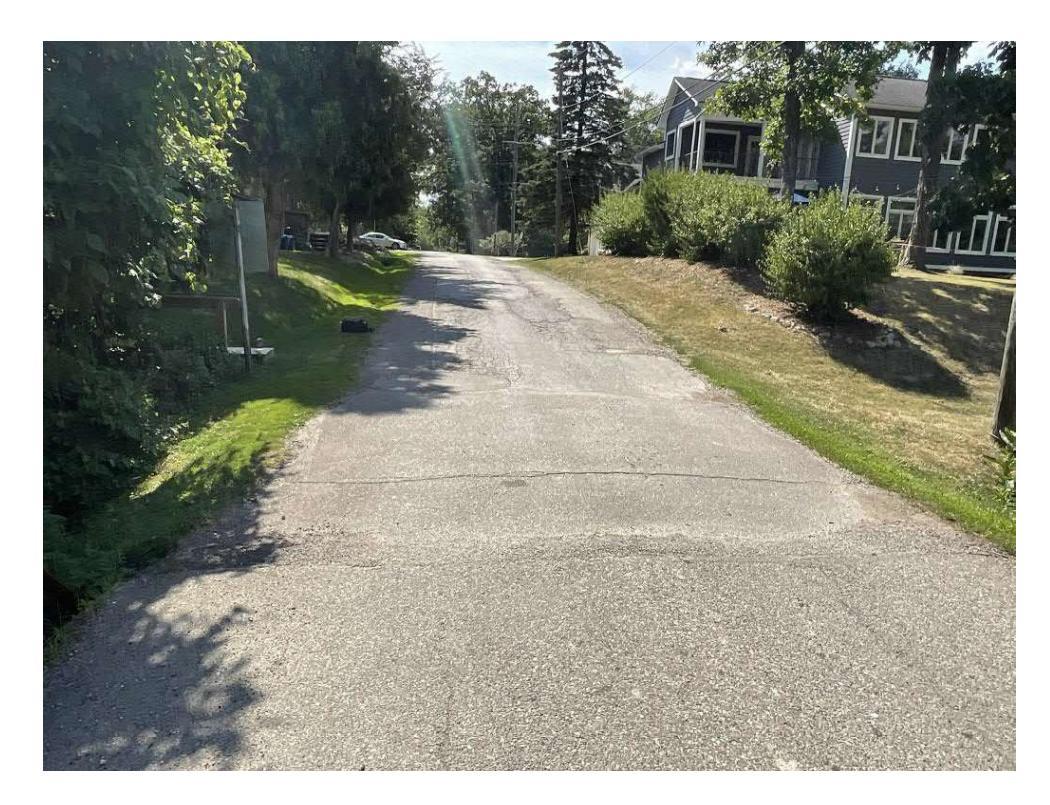
The hot mix asphalt approach pavements are in fair condition with minor settlement in both approaches. The west approach has alligator cracking with two hot mix asphalt cold patches along tire pathway. The east approach has alligator cracking and spalling within 30' of the East reference line.

Name: IMG_0204 (1024x768) Description: West approach

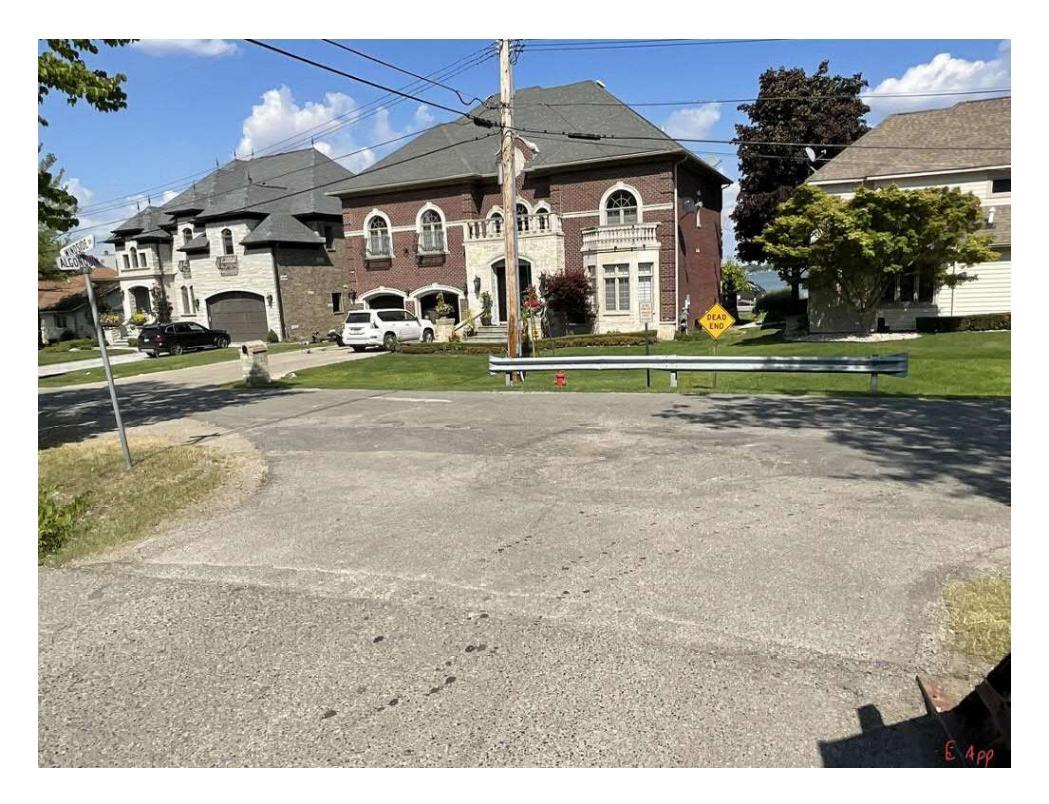
Name: IMG_0205 (1024x767) Description: East approach

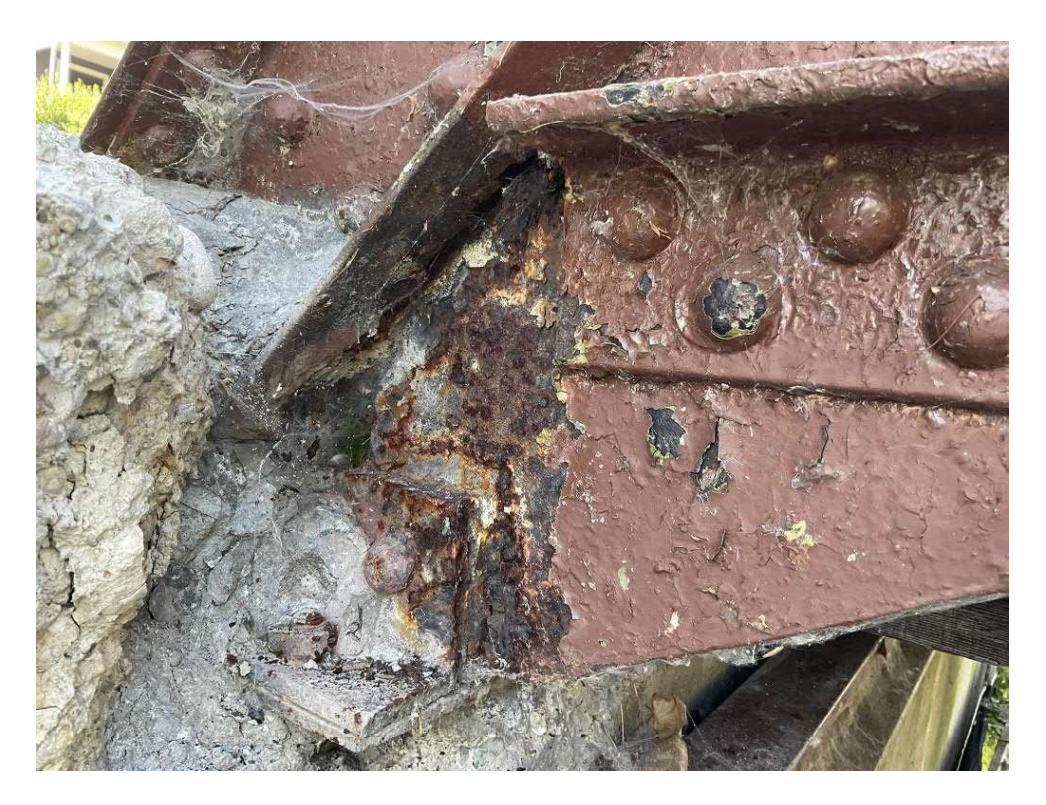
The superstructure has two thru trusses that are in serious condition based on the section loss at the bearings and gusset plates. Load analysis required a reduction of the posting based on severe loss of section at the bearings. Otherwise, the superstructure is in fair condition with paint peeling throughout.

Name: IMG_0208 (1024x768) Description: L0 South side, holes in bearing

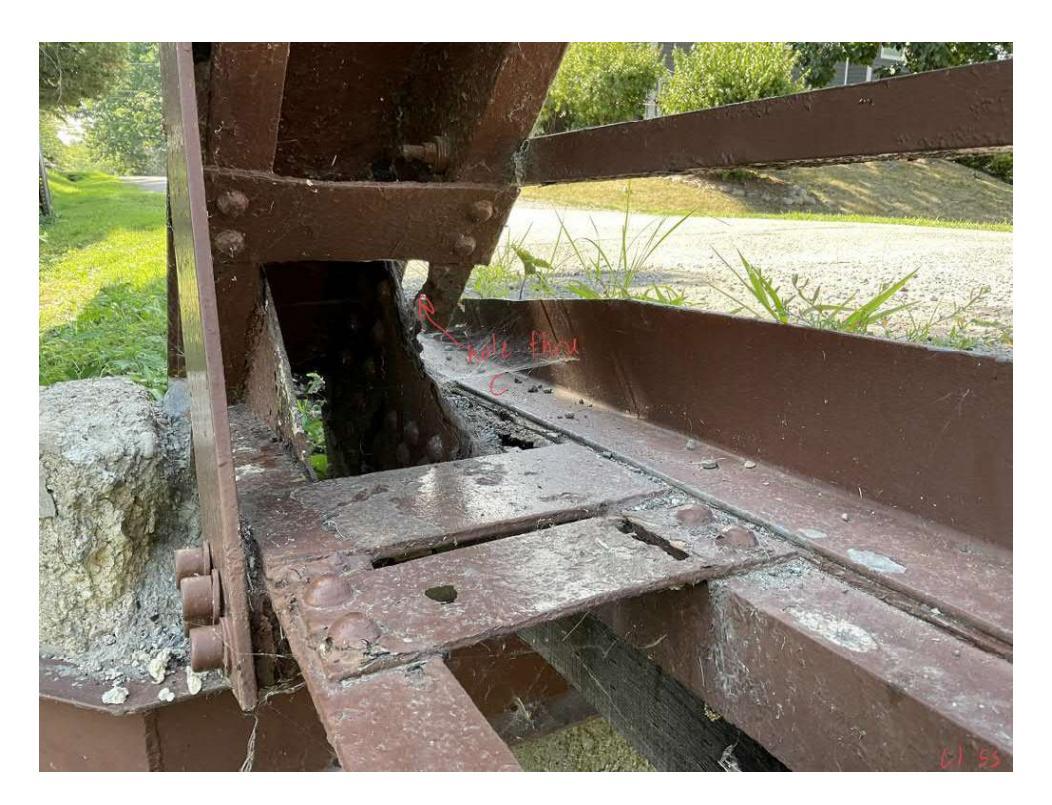
Name: IMG_0210 (1024x767) Description: L0 south side, hole

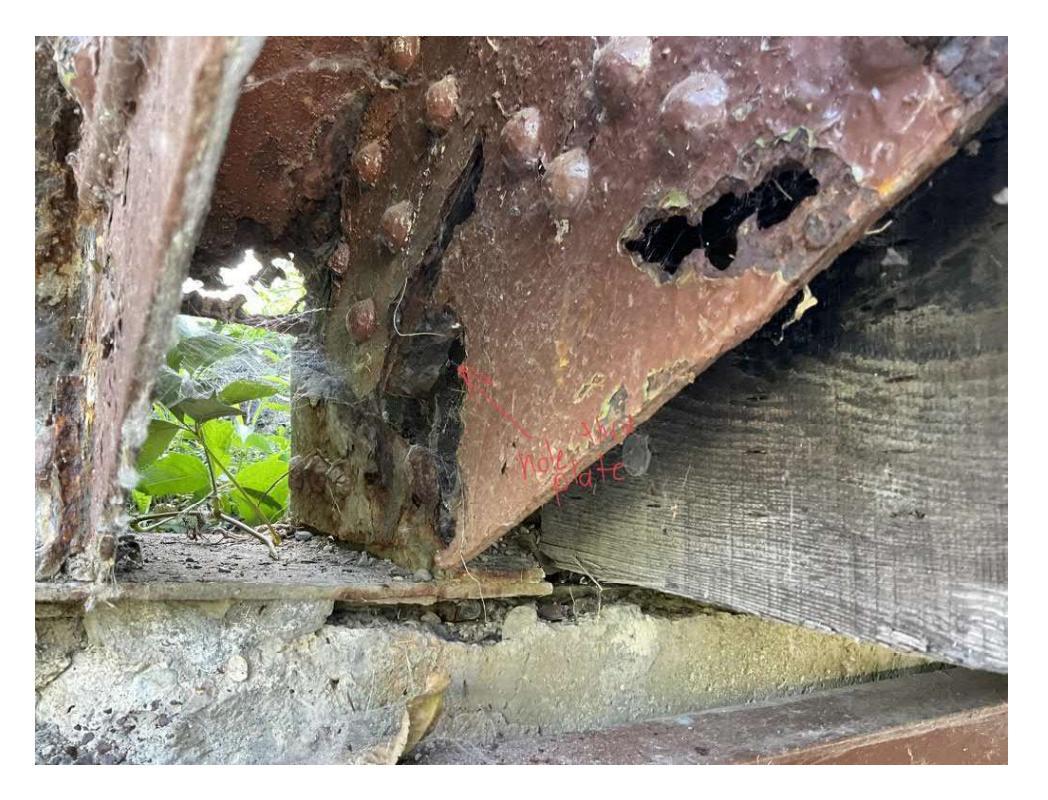
Name: IMG_0211 (1024x767) Description: Hole thru plate

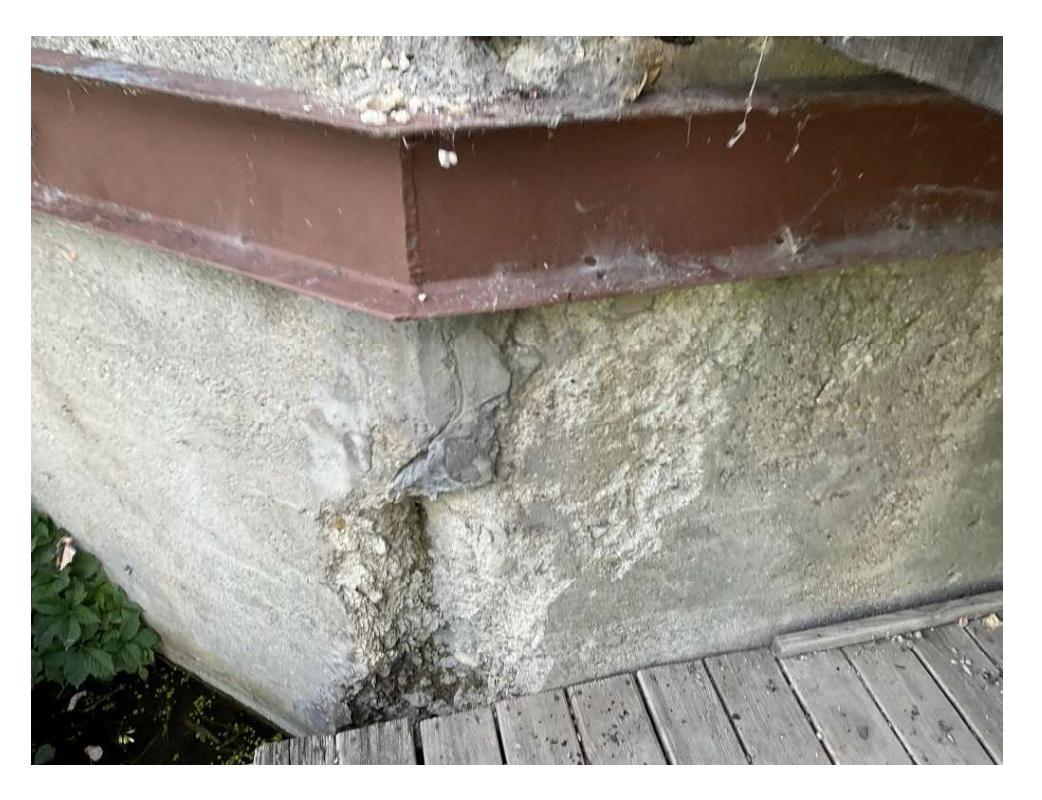
The concrete cantilever abutments are supported by steel piles and are in fair condition. There is a large spall in the Southwest quadrant, however, the concrete has delaminated and spalled off. The surface of both abutments has moderate scaling, but function as designed.

Name: IMG_0226 (1024x768) Description: Spall in south side of west abutment

- Superstructure
 - Replacement
- Substructure
 - o Scarify and repair bearing concrete & delaminated concrete
- Approach
 - Replace 5' of both approaches
