# Main Street – High St to Columbia Ave Corridor

City of Belleville, Wayne County, MI

## Road Safety Audit

# FINAL REPORT

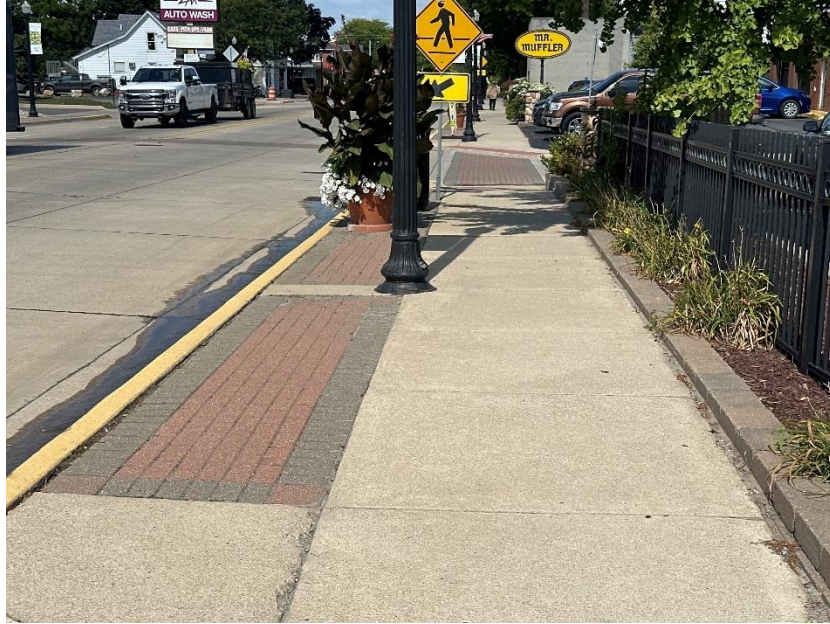
- Sidewalk Conditions – sidewalks were found to be in generally good condition.

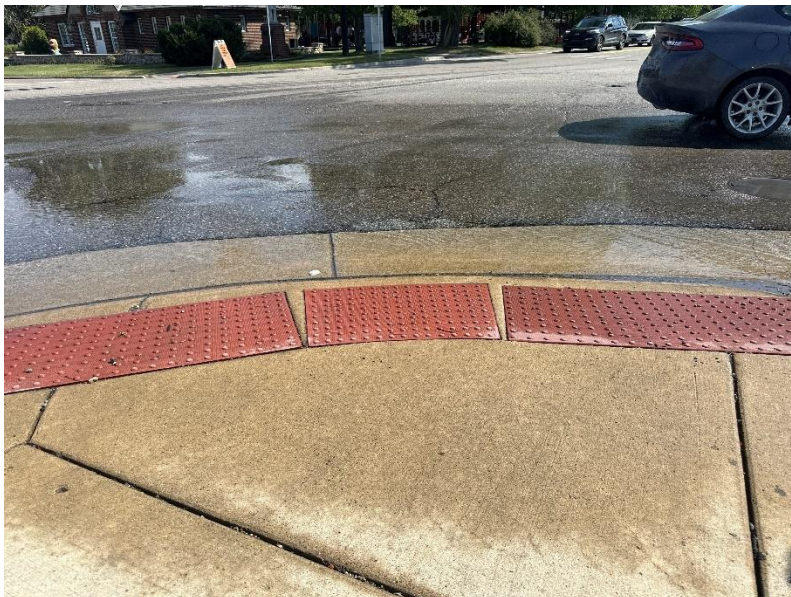
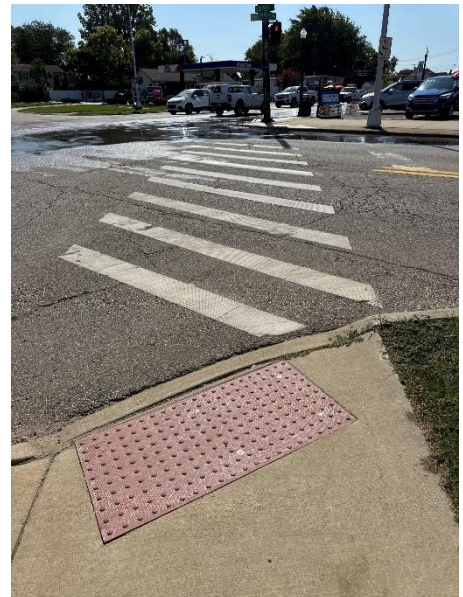
- Ramp Conditions – the ramps were found to be ADA compliant and generally in good condition.

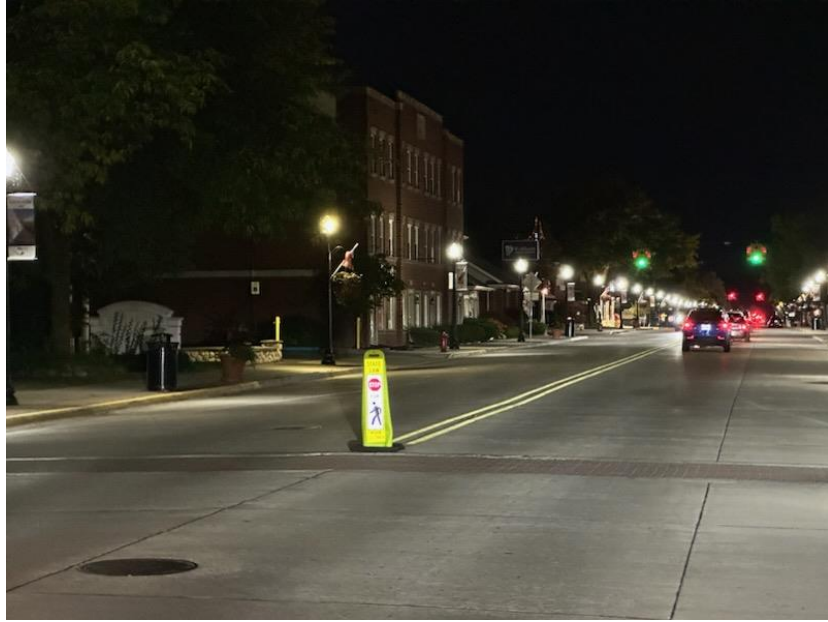
- Corridor Lighting – ample lighting was observed along the corridor from streetlights and businesses.

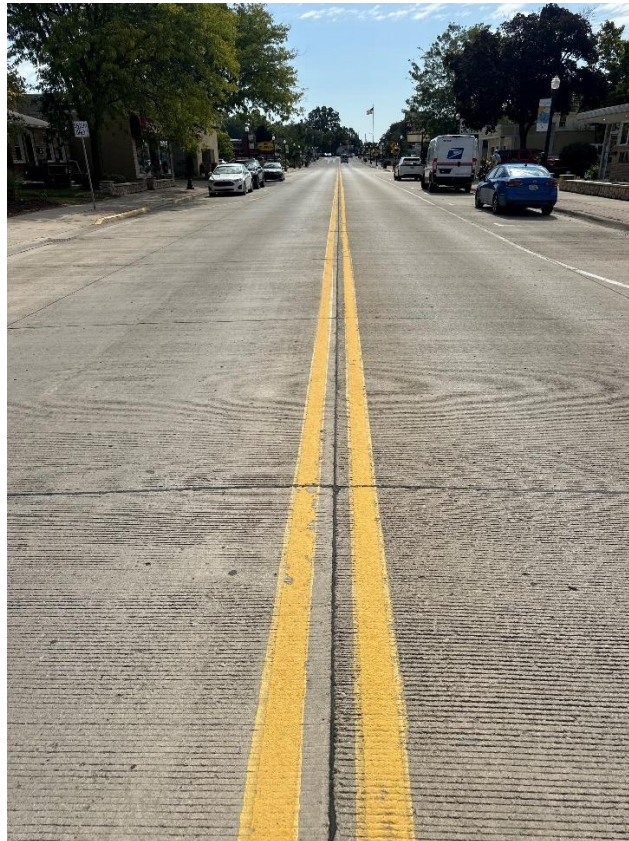
- Pavement Condition and Maintenance – pavement is generally in good condition and has been well maintained.

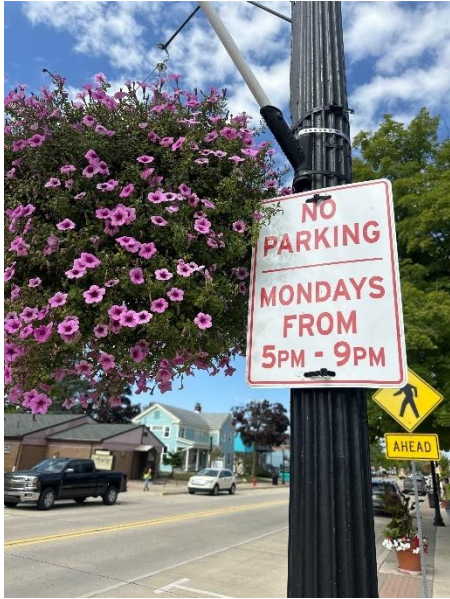
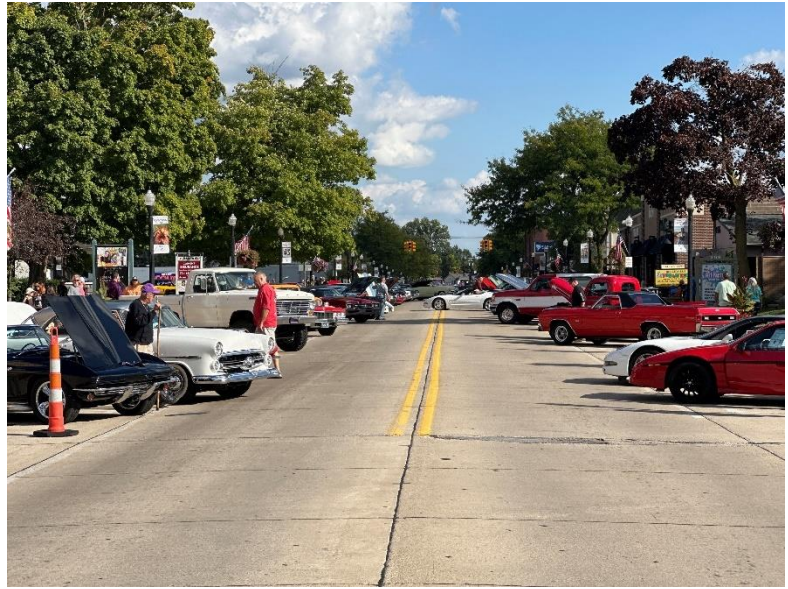
- Plan for Activities – evidence shows that the streets are well maintained and organized for city events.

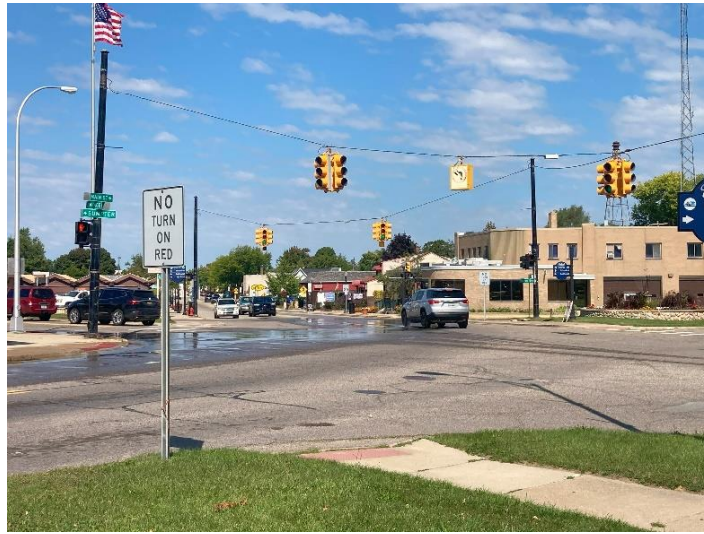
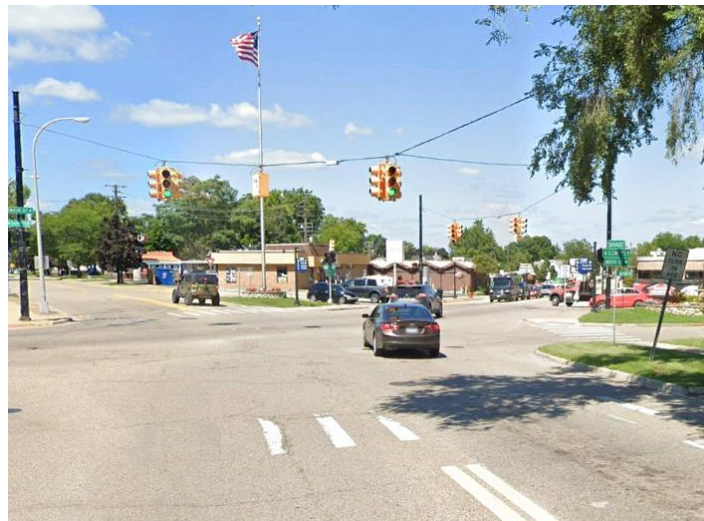
### **5.1 Crash Potential #1 (Risk Category F) – 5 Point Intersection**

- The existing lane configuration is confusing to drivers due to the lack of signs or markings.
- There is an unconventional signal head configuration and phasing at this intersection that causes many red-light running incidents.
- The visibility of the signals for some approaches is poor due to signal head placement on the diagonal spans.

Lane arrows and guideline pavement markings can help mitigate the drivers to know where they are supposed to be going for their next movement. Lane designation signing can also help mitigate the issues at the intersection with allowing signage to illustrate where certain directions of traffic will be going. The intersection can also benefit from a modernize signal to box span with programmable lenses and countdown pedestrian signals. The programmable lenses will cause drivers to only view the signal once they are at/approaching the signal. This allows drivers to not misinterpret the signals ahead of them and minimize red light running.

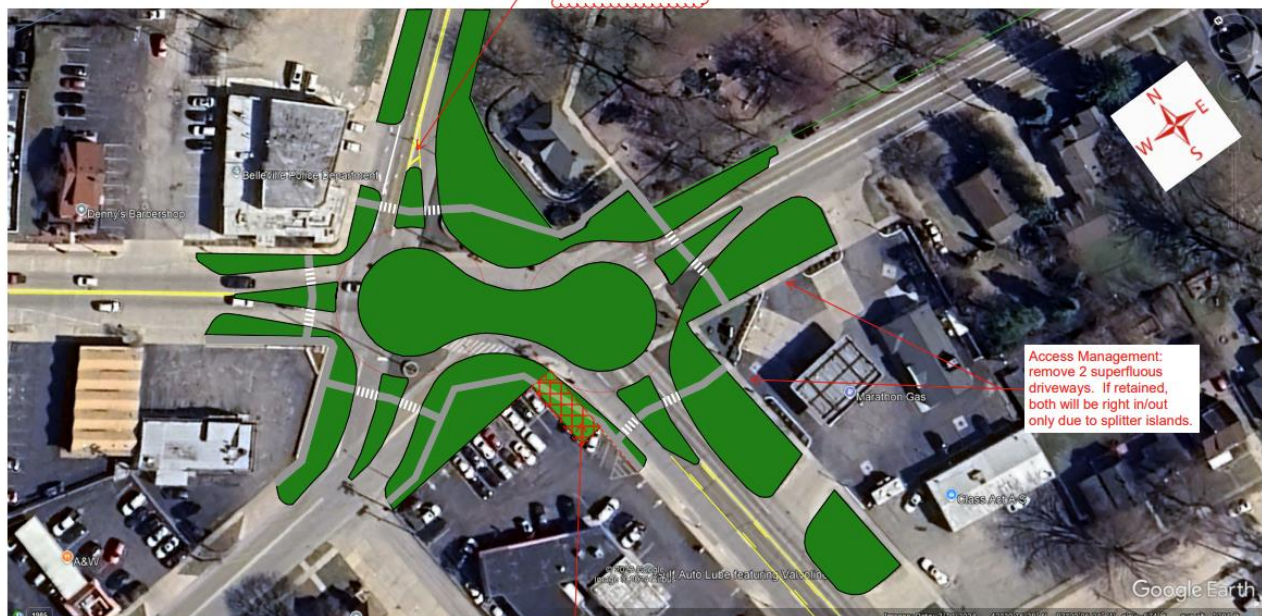
### Belleville 5 Points:

Main St, South St, Hudson River Dr,  
East Columbia Ave and West Columbia Ave.

- \* Single lane approaches / departures
- \* Inscribe circles ~100' dia.
- \* Circulating road lane width ~15'
- \* Approach /departure lane width 12' flare to ~ 14'

A long-term improvement would be to install a single lane roundabout in place of this complicated intersection. A roundabout will help lower crash severity along with providing better safety to pedestrians. The proposed roundabout will allow for bigger vehicles like trucks and school buses to easily pass through. The proposed roundabout will also be able to accommodate snowplows/trucks during winter months or when harsh weather conditions are experienced. A similar shaped roundabout was recently built in Michigan at S Dearing Rd and McClain Road in Jackson County, Michigan. Another example is at Golden Hill Rd and Union Rd in Paso Robles, California.

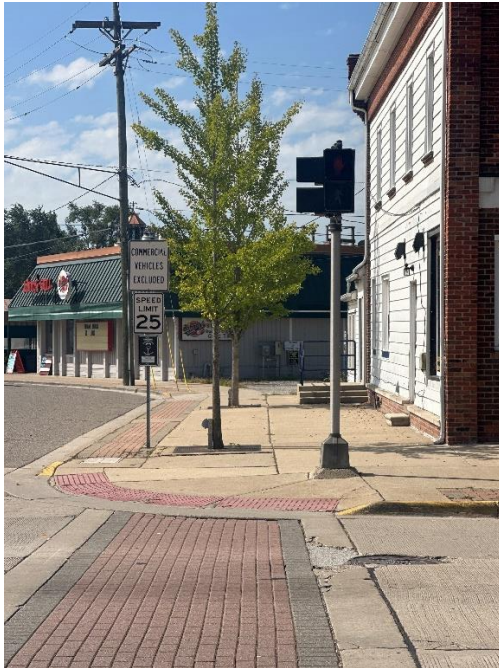
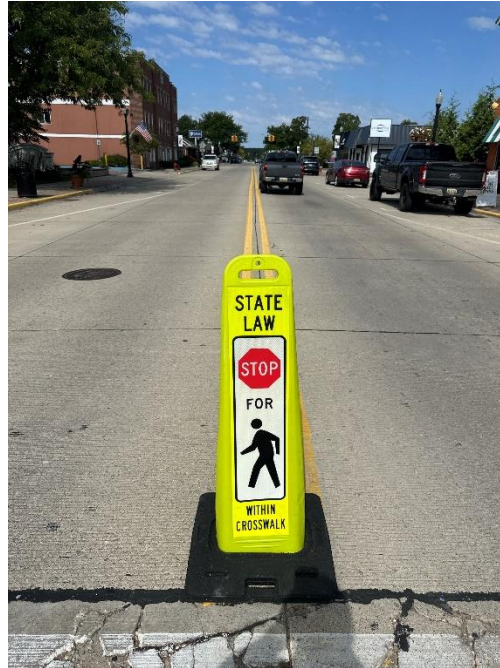
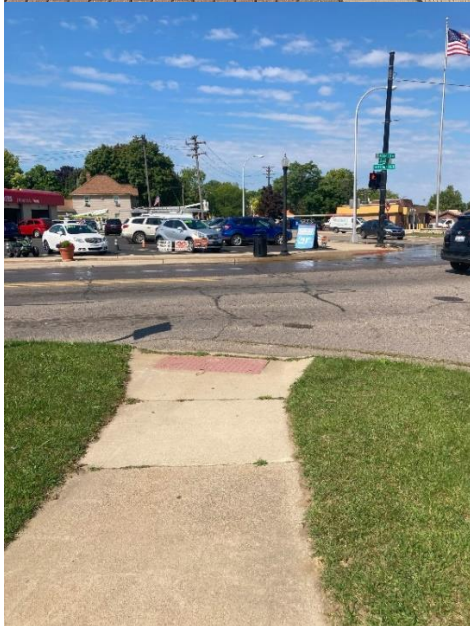
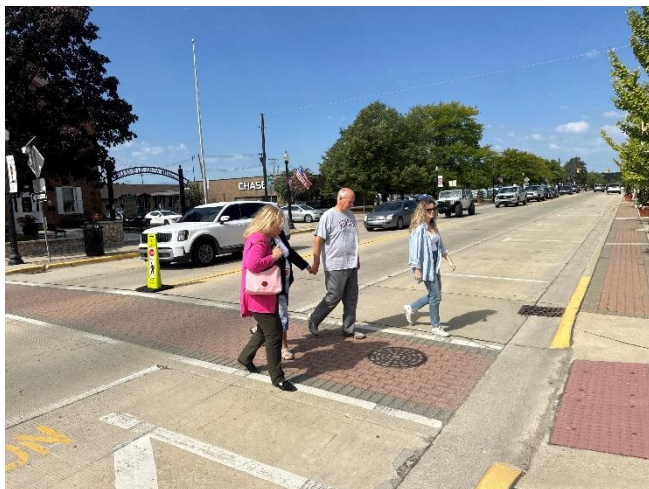
## 5.2 Crash Potential #2 (Risk Category E) – Pedestrian Facilities

- Some pedestrian signals throughout the corridor were non-functional and not providing any direction to pedestrians trying to cross the street.
- Most of the pedestrian signals did not have countdown indication or pedestrian detection.
- The signs placed in the crosswalk (R1-6) did not have the correct sign legend, there is not a State Law in Michigan stating to stop for pedestrians within crosswalk. The sign should say yield, or if a local ordinance is in place the legend should say LOCAL LAW.
- The pedestrian ramps did not line up correctly when crossing South Street at E. Columbia Ave.

- Add table-top (aka speed hump) pedestrian crossings at existing mid-block pedestrian crossings within the corridor to allow safer passage for pedestrians across the roadway by slowing down vehicles. (4<sup>th</sup> Street)
- Add curb extensions within the corridor to help with providing a shorter crossing distance for pedestrians (2<sup>nd</sup> Street, 3<sup>rd</sup> Street)
- Install RRFB at mid-block crosswalks to provide better visibility of pedestrians to drivers.
- Install pushbuttons at signalized intersections with crosswalks.

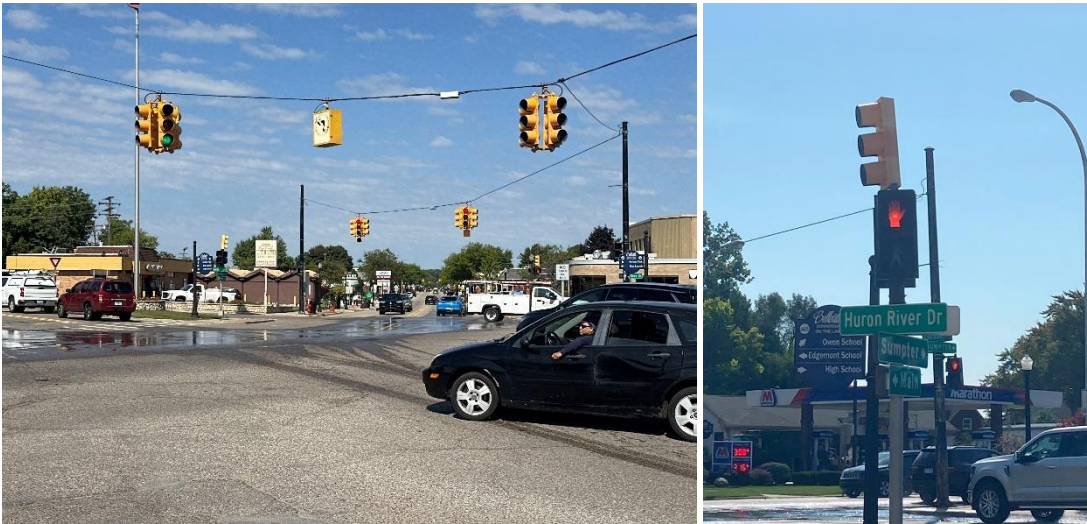
### 5.3 Crash Potential #3 (Risk Category E) – Traffic Signals

- The existing spans are diagonal spans for all intersection in the corridor.
- There are some signal heads that utilizing eight-inch lenses.
- The traffic signals do not have great visibility and are lacking backplates.
- The pedestrian signals are not countdown pedestrian signals.

- Install box span signals with backplates to increase the visibility of the signals to drivers.
- Install countdown pedestrian signals so pedestrians know how much time they have to cross.

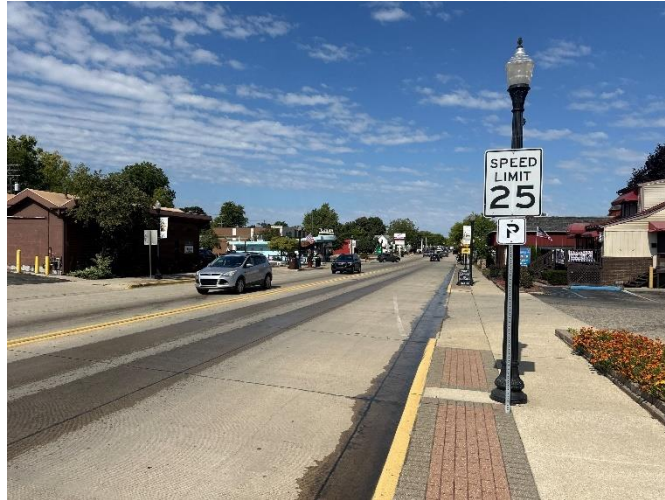
#### 5.4 Crash Potential #4 (Risk Category D) – Speeds

- Drivers “race to merge” on the roadway causing increased speeds.
- Police officer reports speeding issues on north end and throughout downtown area.

- Install speed limit signs after each cross street and ensure that current signs are visible.
- Install a mini-roundabout or mini-circle at 3<sup>rd</sup> Street and Main Street as a traffic calming device.

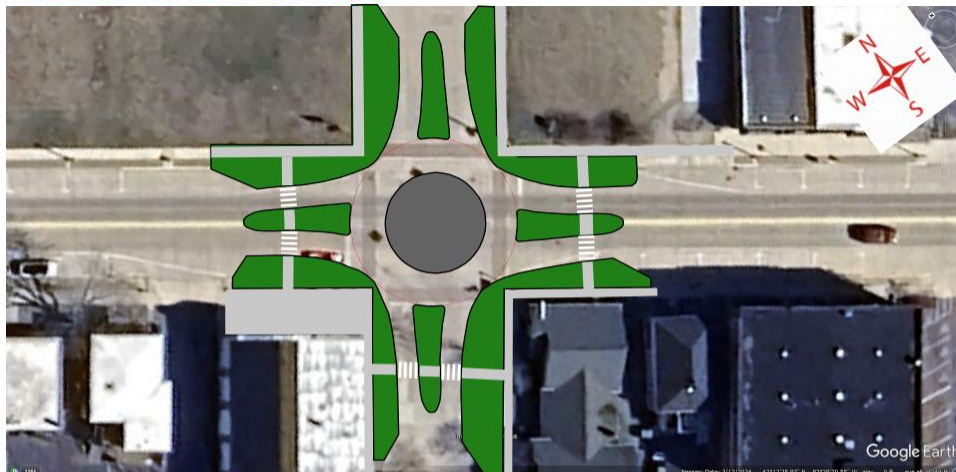
##### Belleville Main St at 3rd St

- \* Single lane approaches / departures
- \* Inscribe circles ~70' dia.
- \* Circulating road lane width ~14'
- \* Approach /departure lane width 11' flare to ~ 13'

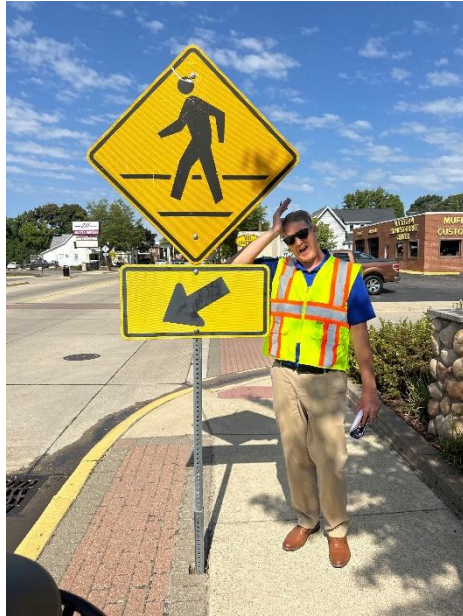
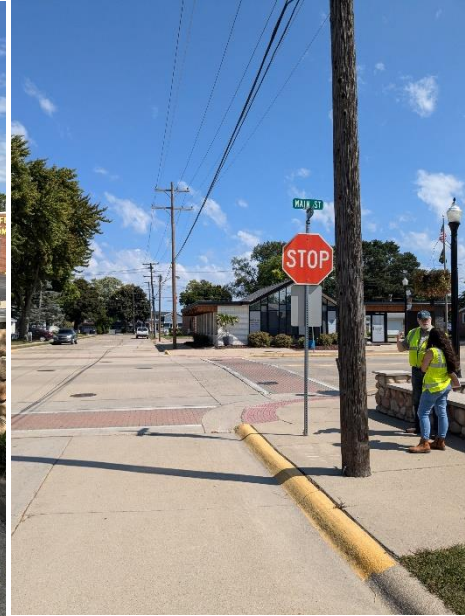
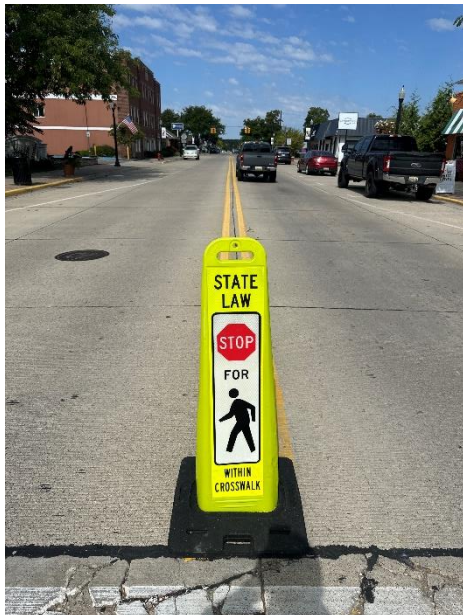
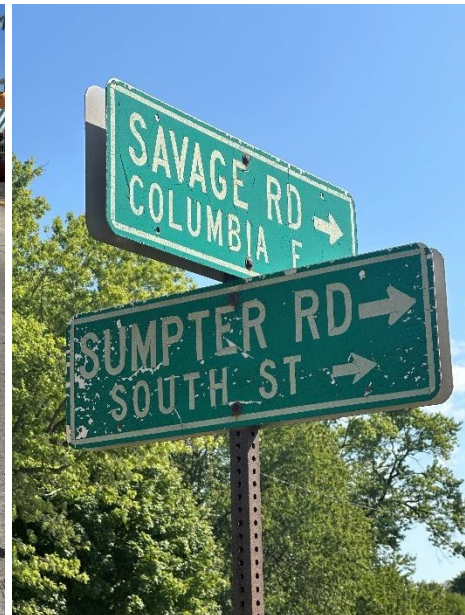
## 5.5 Crash Potential #5 (Risk Category D) – Signing

- Some signs have outdated designs (pedestrian crossing warning) and are very old with poor retroreflectivity.
- There is a lack of lane designation and speed limit signs within the corridor.
- Signs on the corridor are mounted too low for pedestrians.
- There are signs sharing post with stop signs that are not permitted per the MUTCD.

- Upgrade signs throughout the corridor for proper messaging, sizes, placement, and retroreflectivity.
- Install lane designation and turn prohibition signing.

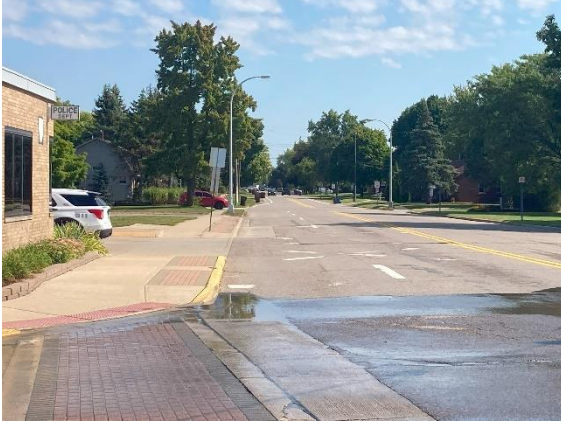
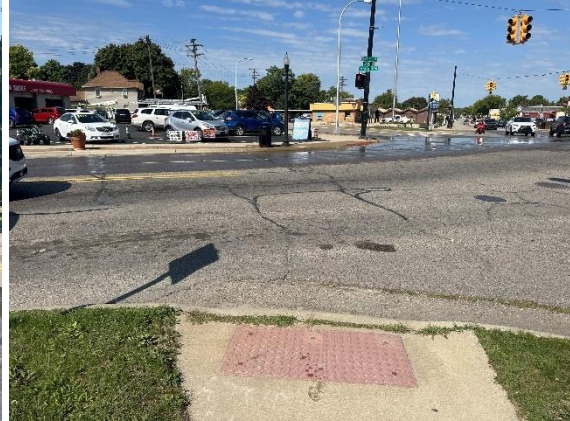
## **5.6 Crash Potential #6 (Risk Category C) – Pavement Markings**

- Existing transverse and special markings are faded and not visible to drivers.
- Lane designation arrows are missing on existing roadway. These lane use markings along with proper signing help drivers to know which lanes they should be in.

- Refresh pavement markings with durable markings.
- Add lane designation arrows onto roadway.

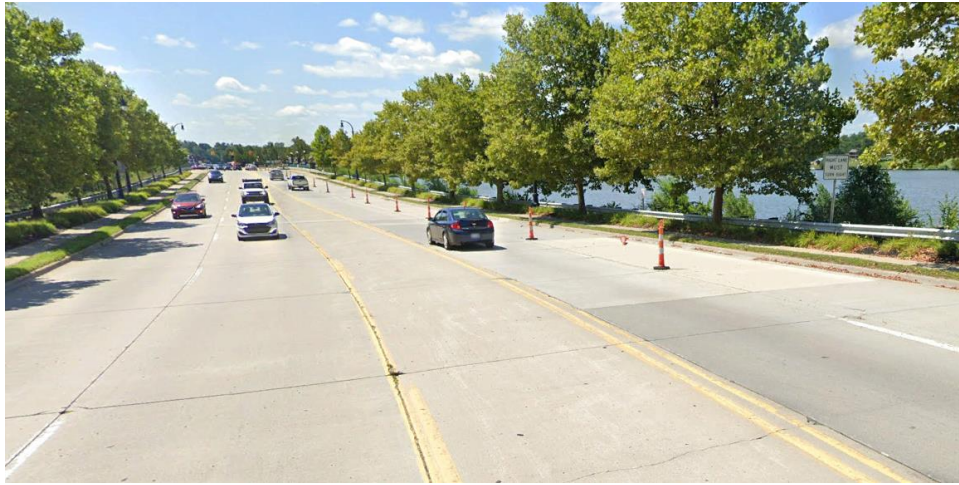
#### **Advance Lane Drop**

- Main Street before Denton Road is missing signage to illustrate a dropped lane at Denton Road.

- Install advance lane drop signage north of Denton Road.
