HOUSE of REPRESENTATIVES

Appropriations Requests for Legislatively Directed Spending Items

4. Name of the entity that the spending item is intended for:
Grand Rapids Art Museum
5. Physical address of the entity that the spending item is intended for:
101, Monrow Center St NW, Grand Rapids, MI 49503

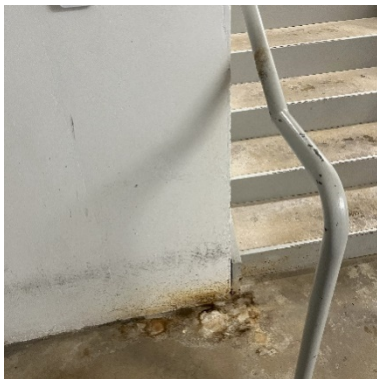
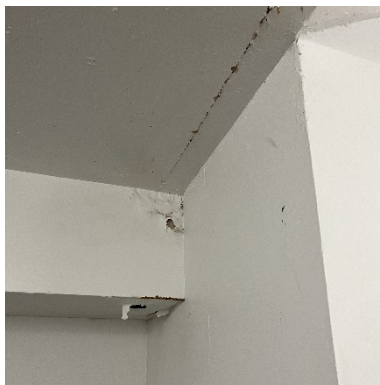
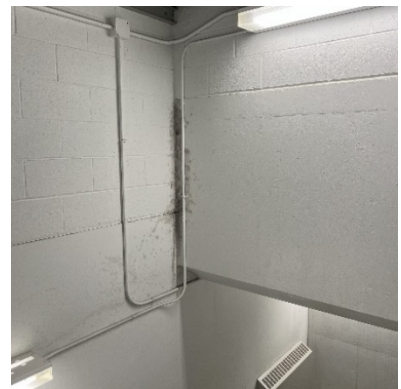
Recommendations: Various repairs due to roof leaks that have been addressed with a new roof.

- Mitigate mold in corner of wall shown in photo.
- Repair and prime, with rust inhibitor, the ceiling crack shown in photo.
- Remove bulkhead construction. Reconstruct after addressing hidden deficiencies.
- Clean and reseal floor at stair landing from stair to Security entry door.
- Descale handrail, grind and repaint with rust inhibitor.

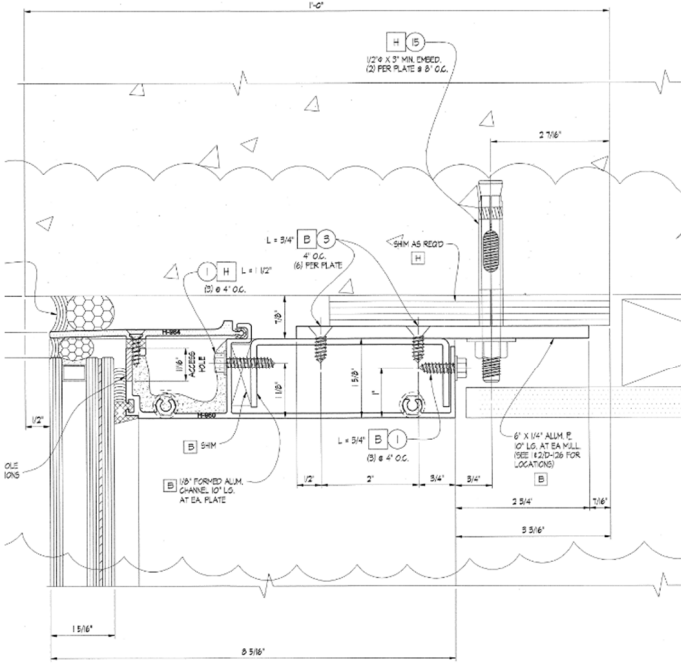
1 TOP HORIZONTAL AT VISION WINDOW @ LIBRARY
 SCALE: FULL SIZE REF: C2 / A654 2-117

Curtainwall Shop Drawing
 'very cold' window section
 without thermal breaks.

Replacement of the window system may be the only solution to eliminate the condensation.

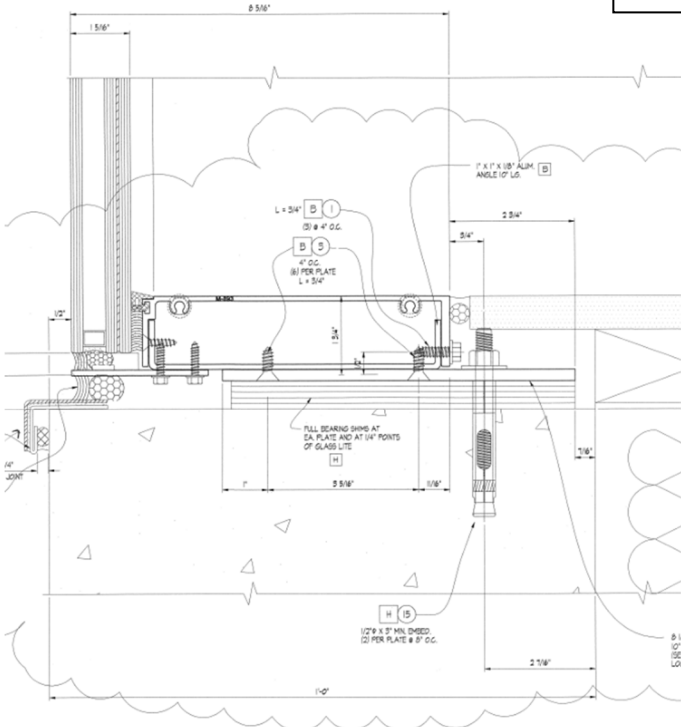
1 SILL AT VISION WINDOW @ LIBRARY
 SCALE: FULL SIZE REF: C2 / A654 2-117

Curtainwall Shop Drawing
'Very cold' window section
without thermal breaks. A cold
path directly into building using
high humidity.

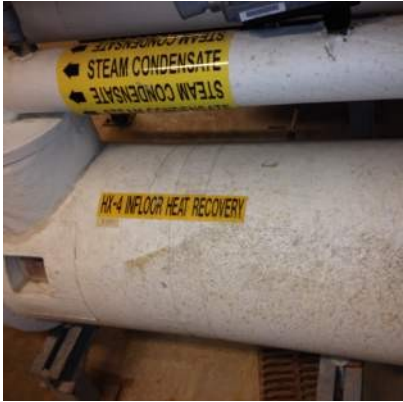
UniFormat Section: D3020.10 - Heat Generation
Name: Steam Heat Exchanger
Priority: Low (5- 10 years)
Location: Mechanical Room
Manuf Type: N/A
Today's Cost: N/A
Observation: Main heating system steam to water heat exchanger, 480 gpm capacity.
Reason for Replacement: Age / Useful Life
Evaluation Rating: 5 - All functions perform
Recommendations: Replace HX when useful life ends. No reported issues with the system.

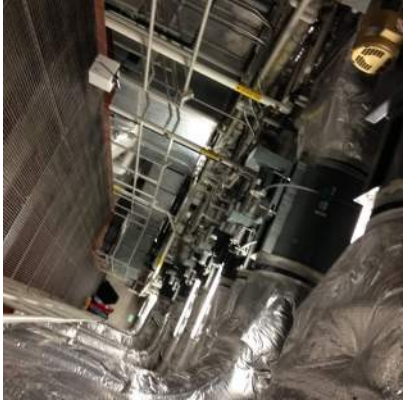
UniFormat Section: D3060.10 - Supply Air
Name: Supply Plenum
Priority: Moderate (1 - 5 years)
Location: Mechanical Room
Manuf Type: N/A
Today's Cost: N/A
Observation: Supply air plenum was found to mix air temperature and humidity well enough.
Reason for Replacement: Energy Efficiency
Evaluation Rating: 3 - Some functions do not perform
Recommendations: Functions well, no comment.

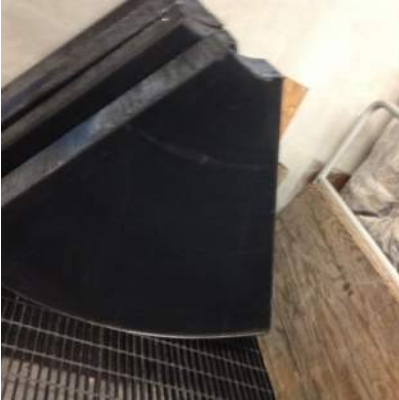
UniFormat Section: D3070.10 - Snow Melting
Name: Steam Heat Exchanger
Priority: Low (5- 10 years)
Location: Mechanical Room
Manuf Type: N/A
Today's Cost: N/A
Observation: Snowmelt system steam to water heat exchanger, 100 gpm capacity.
Reason for Replacement: Age / Useful Life
Evaluation Rating: 5 - All functions perform
Recommendations: Replace when useful life ends. No problems reported with this system.

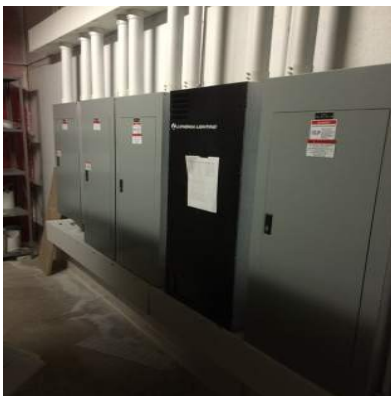
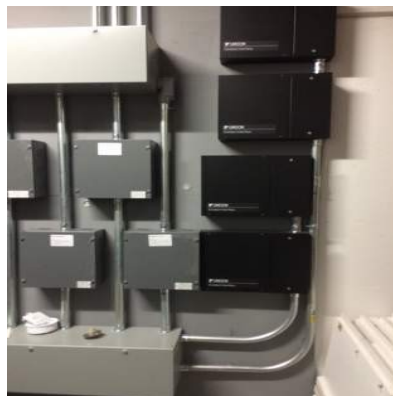
Reason for Replacement: The lighting control system is obsolete and obtaining replacement and obtaining replacement hardware is becoming more difficult as time goes on.

Evaluation Rating: 3 - Some functions do not perform

Recommendations: Due to the age, functional issues and obsolescence of the lighting control system it is recommended to replace with an up to date system. Recommend an Acuity nLight or equivalent system. A wireless control system should be considered to add flexibility in controlling fixtures where current zoning may not be desired in hard lid ceilings.

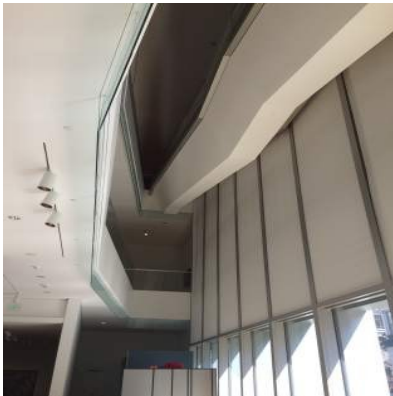
UniFormat Section: D5040.50 - Lighting Fixtures
Name: Incandescent Lamp track fixtures
Priority: Moderate (1 - 5 years)
Location: 3rd Level Gallery
Manuf Type:
Today's Cost: \$20,000
Observation: The 3rd floor gallery has incandescent track lighting that has various spotlights.
Reason for Replacement: Energy Efficiency
Evaluation Rating: 5 - All functions perform
Recommendations: Replace track heads with LED type compatible with existing track systems to provide more energy efficient light fixtures.

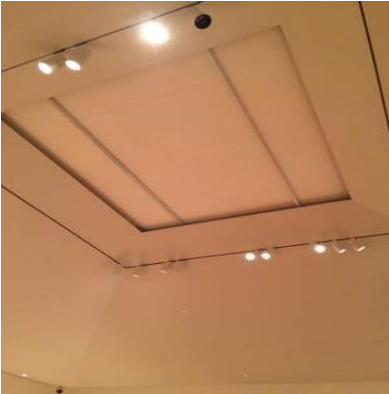
UniFormat Section: D5040.50 - Lighting Fixtures
Name: Recessed downlight fixtures
Priority: Moderate (1 - 5 years)
Location: 3rd Level Gallery
Manuf Type:
Today's Cost: \$100,000
Observation: The 3rd floor gallery has recessed downlight fixtures that have the lamps removed due to inability to dim or turn off separate from the track lighting and are too bright at certain times of day.
Reason for Replacement: Energy Efficiency
Evaluation Rating: 5 - All functions perform
Recommendations: Replace downlights with LED type and add on/off/dimming controls to add flexibility in space.

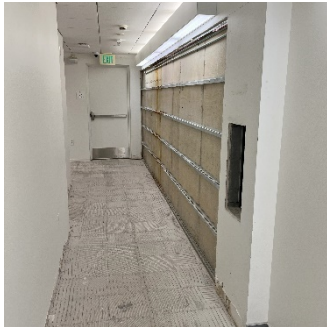
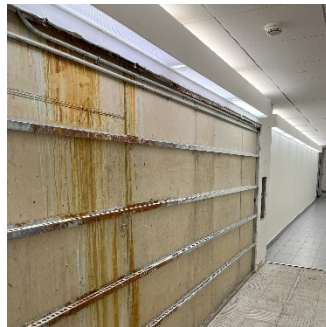
Evaluation Rating: 1 – Non-functioning

Recommendations: Before any work being done on the interior, exterior deficiencies need to be corrected. (reflecting pool). After confirming that there are no more leaks, do all interior modifications.

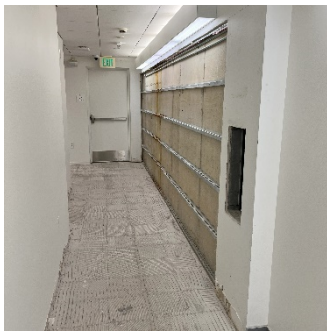
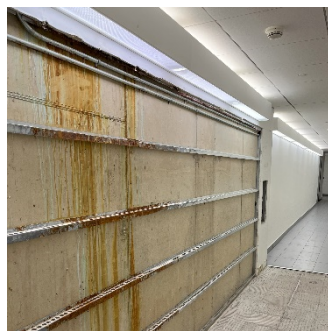
Evaluation Rating: 1 – Non-functioning

Recommendations: Before any work being done on the interior, exterior deficiencies need to be corrected. (reflecting pool). After confirming that there are no more leaks, do all interior modifications.

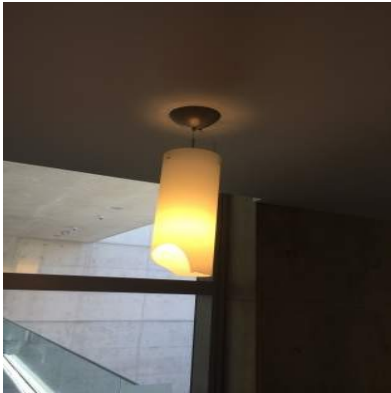
UniFormat Section: D5040.50 - Lighting Fixtures
Name: Italian Pendant Decorative Fixtures
Priority: N/A
Location: 2nd Floor Lounge/Atrium area
Manuf Type:
Today's Cost: \$50,000
Observation: There is a one fixture that has decorative glass that is broken. This is in a prominent public area.
Reason for Replacement: Broken lens
Evaluation Rating: 4 - Most functions perform
Recommendations: Replace portion of fixtures and store for attic stock for remaining.

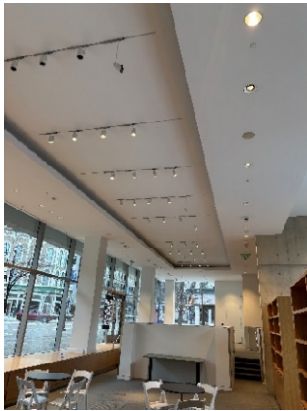
UniFormat Section: D5040.50 - Lighting Fixtures
Name: Old Museum Shop
Priority: Moderate (1 - 5 years)
Location: First Level
Manuf Type:
Today's Cost: \$68,000
Observation: Fixtures are incandescent and fluorescent type except in recently renovated area on second floor.
Reason for Replacement: Energy Efficiency, maintenance cost
Evaluation Rating: 4 - Most functions perform
Recommendations: Replace the existing fixtures with an LED equivalent.

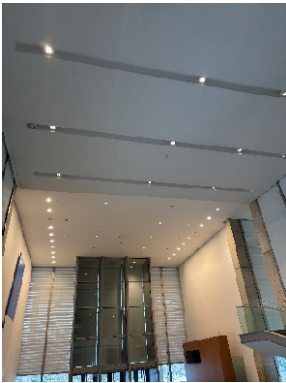
UniFormat Section: D5040.50 - Lighting Fixtures
Name: Lobby
Priority: Moderate (1 - 5 years)
Location: First Level
Manuf Type:
Today's Cost: Included in total from second level offices.
Observation: Fixtures are incandescent and fluorescent.
Reason for Replacement: Energy Efficiency, maintenance cost
Evaluation Rating: 4 - Most functions perform
Recommendations: Replace the existing fixtures with an LED equivalent.

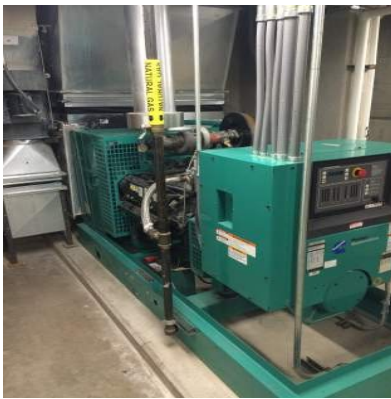
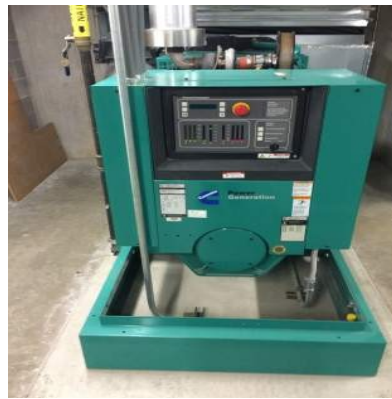
UniFormat Section: D50 - Electrical
Name: Emergency Generator System
Priority: N/A
Location: Electrical Room Basement Level
Manuf Type: Cummins
Today's Cost: N/A
Observation: Current generator appears to be in great condition and has been run each month as required to meet the codes. There has been no significant change in the loads from the original construction of the building.
Reason for Replacement: N/A (No replacement planned)
Evaluation Rating: 5 - All functions perform
Recommendations: Continue to do monthly testing and yearly maintenance to improve the longevity of the unit.

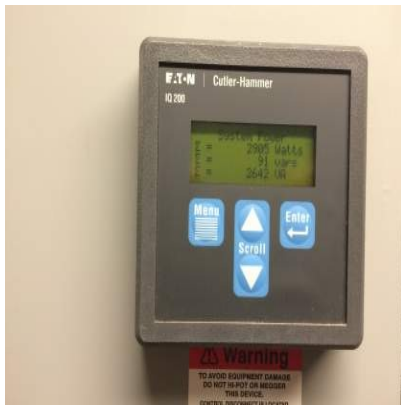
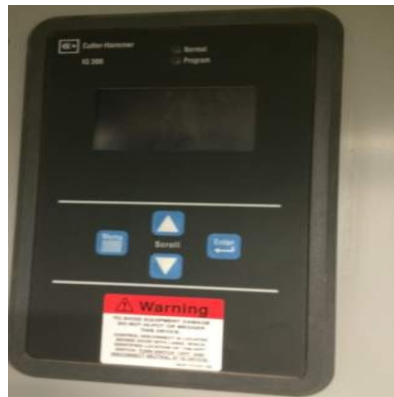
UniFormat Section: D5010.90 - Facility Power Generation Supplementary Components

Name: Metering Equipment

Reason for Replacement: N/A (No replacement planned)

Evaluation Rating: 5 - All functions perform

Recommendations: None at this time.

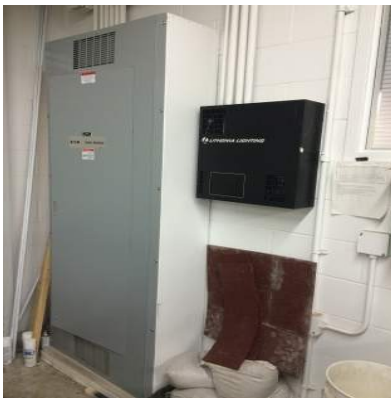
UniFormat Section: D5040.10 - Lighting Control
Name: Lithonia Lighting System
Priority: N/A
Location: Lower Level Loading Dock area 012
Manuf Type: Lithonia
Today's Cost: \$160,000
Observation: The lighting controls system is experiencing functionality issues.
Reason for Replacement: The lighting control system is obsolete and obtaining replacement hardware becoming more difficult as time goes on.
Evaluation Rating: 3 - Some functions do not perform
Recommendations: Due to the age, functional issues and obsolescence of the lighting control system, it is recommended to replace in kin with an up to date system.

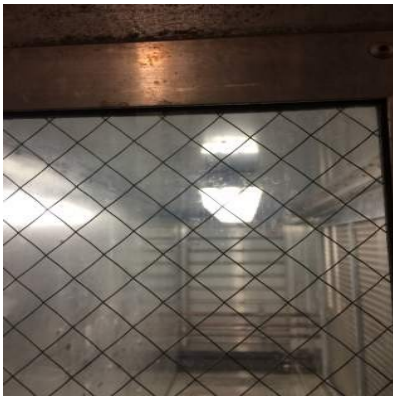
UniFormat Section: D5040.50 - Lighting Fixtures
Name: Mechanical Light fixtures
Priority: Low (5 - 10 years)
Location: Mechanical Equipment in basement level
Manuf Type: Lithonia
Today's Cost: \$5,000
Observation: The current light fixtures in the larger mechanical equipment utilizes 2 lamp fluorescent surface mounted fixtures.
Reason for Replacement: Energy Efficiency
Evaluation Rating: 5 - All functions perform
Recommendations: It is recommended to replace these fixtures with LED equivalent when they fail with LED fixtures utilizing less wattage and reducing maintenance requirements.

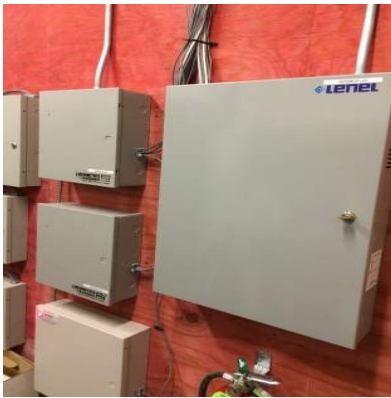
UniFormat Section: D70 - Electronic Safety and Security
Name: Door Hardware Systems
Priority: N/A
Location: Various locations throughout the facility
Manuf Type: Lenel, Locknetics
Today's Cost: N/A
Observation: Current system appears to be functioning and operating efficiently.
Reason for Replacement: N/A (No replacement planned)
Evaluation Rating: 5 - All functions perform
Recommendations:

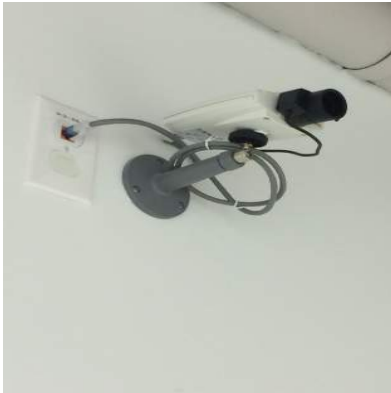
UniFormat Section: D70 - Electronic Safety and Security
Name: Video Surveillance System
Priority: Critical (6 months - 1 year)
Location: Various Locations throughout the building
Manuf Type:
Today's Cost: \$32,500
Observation: Existing system is experiencing issues and components are obsolete.
Reason for Replacement: Age / Useful Life
Evaluation Rating: 4 - Some functions do not perform
Recommendations: Recommend upgrading to new servers.

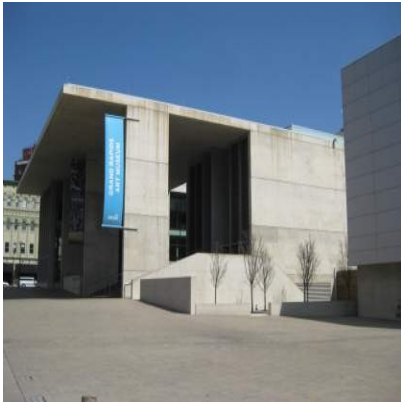
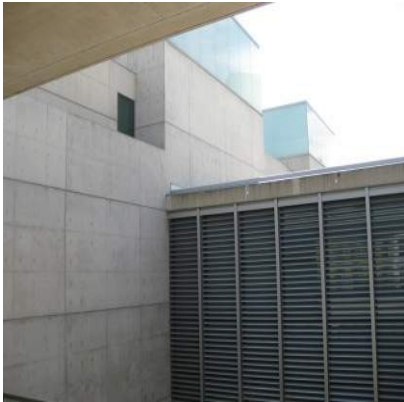
UniFormat Section: B2010.20 - Exterior Wall Construction
Name: Exterior Concrete
Priority: N/A
Location: Parking/Engineering/Bulk Storage, Galleries, Administration, Hospitality
Manuf Type: Custom
Today's Cost: N/A
Observation: All functioning as designed.
Reason for Replacement: N/A (No replacement planned)
Evaluation Rating: 5 - All functions perform
Recommendations: None

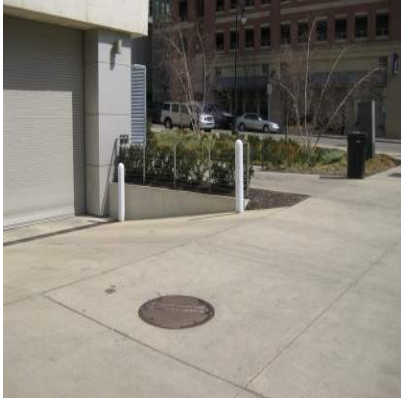
UniFormat Section: B2050.30 - Exterior Oversize Doors
Name: Overhead Coiling Doors
Priority:
Location: Dock Area
Manuf Type: Unknown
Today's Cost: N/A
Observation: See Parking /Engineering/Bulk Storage for observations and recommendations.
Reason for Replacement: N/A
Evaluation Rating:
Recommendations:

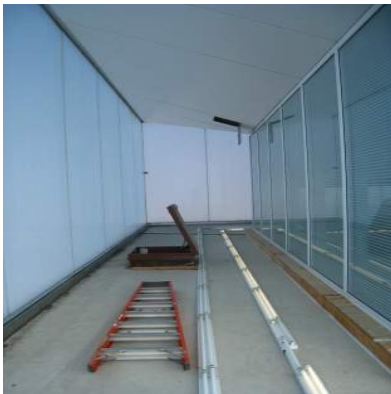
1. Lantern exterior glass frosts over on the interior face on all sides. Likely cause is migration of 90 degree, 48 percent relative humidity air in the upper gallery space. Avenues for migration are over the interior glass wall through the drywall bulkhead, below the glass thru a plywood enclosed continuous curb, and thru the access hatch where bulb seals have failed.
2. Gallery ceilings have water damage due to exposed exterior uninsulated concrete walls; locations are the west corners of the galleries in the gallery plenum space.
3. Gallery exterior walls sweat and leave moisture at the base, possibly due to moisture migrating through the insulation and condensing on the exterior concrete walls.

1. Research at the roof level is needed to resolve water in the conduit.
2. Vapor migration from the Galleries needs further study to propose a resolution.
3. Concrete walls without traditional insulation, condensates (moisture) during winter months and further study is required to resolve.
4. Suggested solution:
 - Add full height aluminum storefront system, with 1/4 inch glass, 4 feet inboard from the exterior translucent panel wall system. This wall will be continuous but with access doors.
 - An HVAC system to be designed for the 4-foot-wide space to control temperature and humidity.
