Appropriations Requests for Legislatively Directed Spending Items

The following pages contain Plante Moran Cresa's (PMC) Facility Assessment of the Royal Oak Public Library. The assessment was based upon visual inspection of the existing building and site conditions, and interviews with library personnel. The documented Facility Report includes operational system improvements related to mechanical, electrical, plumbing, interior finishes, building envelope, and other building systems. While the assessment was not exhaustive or destructive in nature, the intent is for the report to serve as a road map for Royal Oak Public Library for future capital projects related to the facility.

Royal Oak Public Library – Building Information

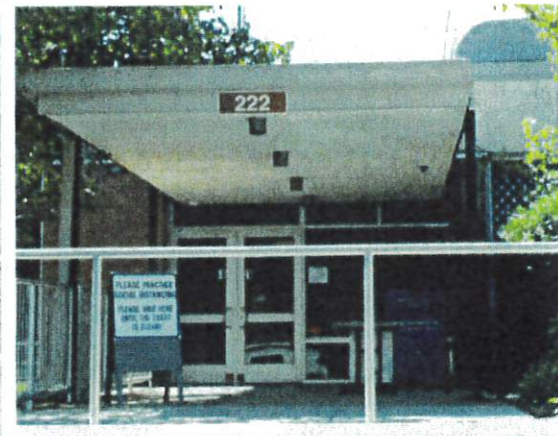
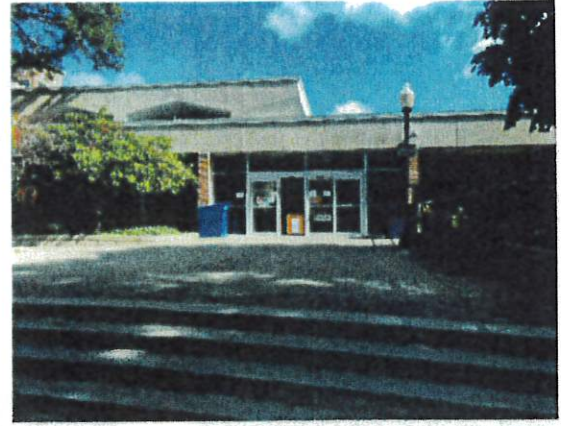
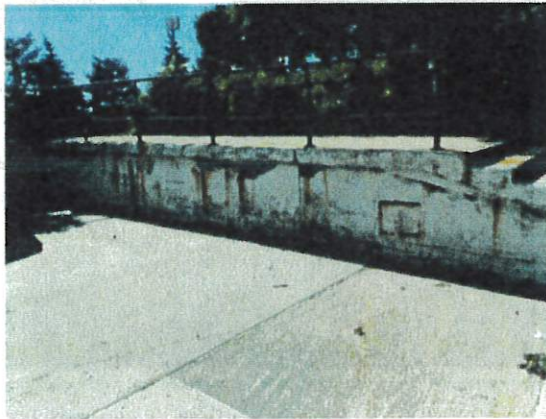
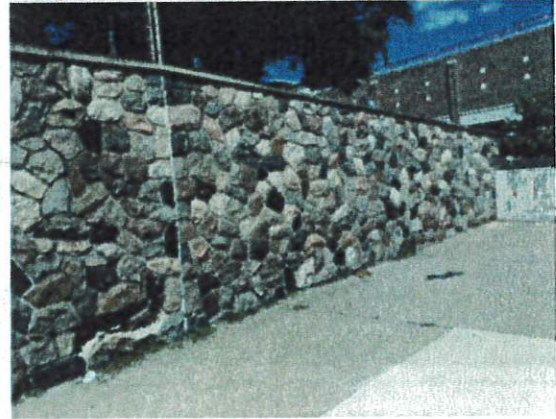
The ADA entrance at the north of the building is a recent addition to the site.

The south side of the library has a large greenspace with copious plantings. There appears to be a handful of dead trees that should be removed. The stone steps and pavers appear to be in good condition with only minor attention required around the base of the trees.

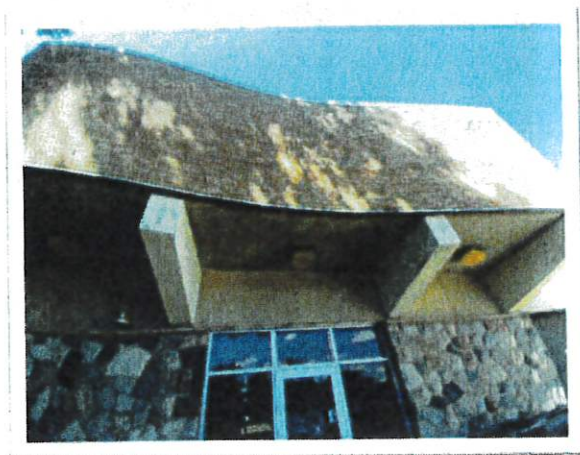
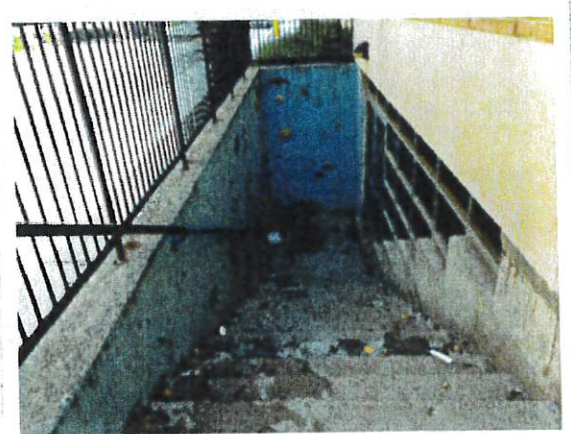
There are many plantings around the building that should be removed and replaced as they are overlarge/ hide the façade or are past their useful life.

The site appears to have adequate drainage.

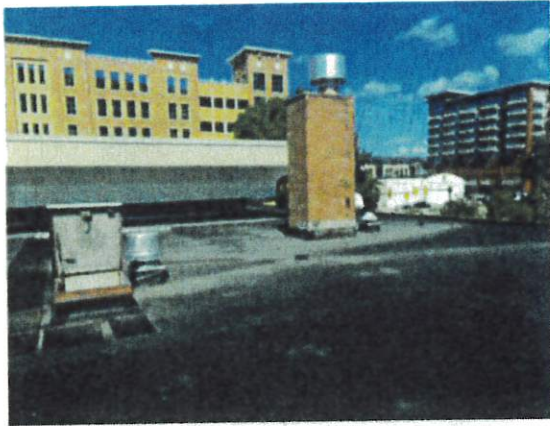
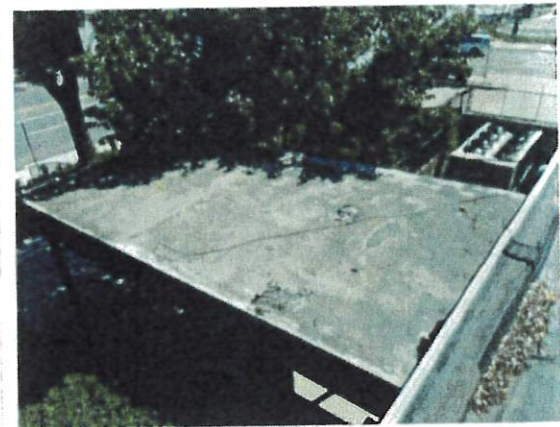
The entire EPDM roofing system was replaced in 2005 with a warranty that will continue through 2025. The roof on the main north canopy is the only roofing not replaced with the last renovations. It is recommended that minimally this roofing should be replaced if the canopy is to remain.

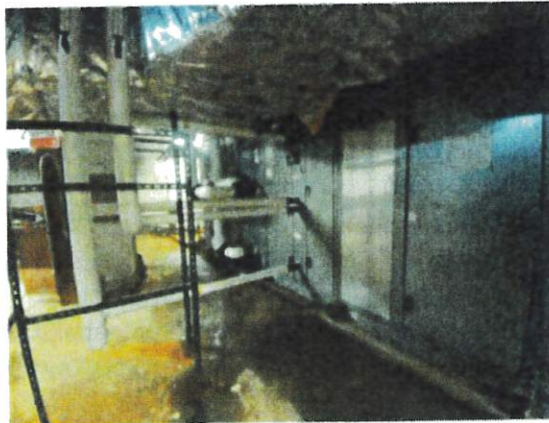
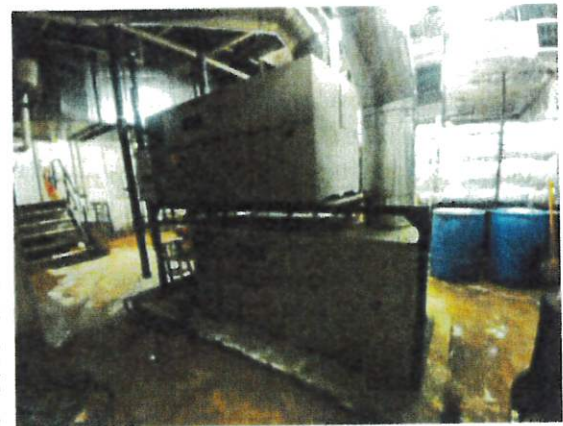
The building heating, ventilating and cooling system was replaced with the 2006 renovation and includes two Lochinvar boilers, pumps, air handling units and water heater. There is a wall mounted split system unit in the IT/Equipment room that appears to be functioning properly.

The mechanical room appears to have perimeter water infiltration and should be investigated by a licensed professional to determine the best course of correction.

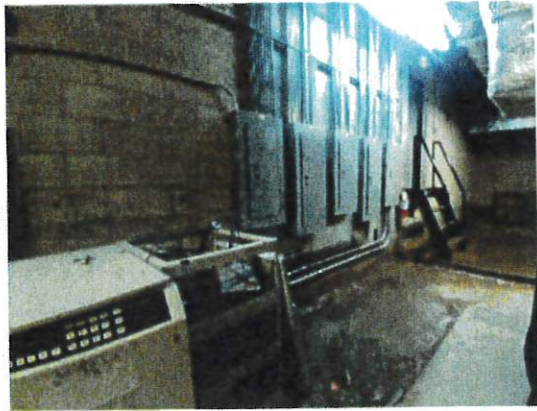
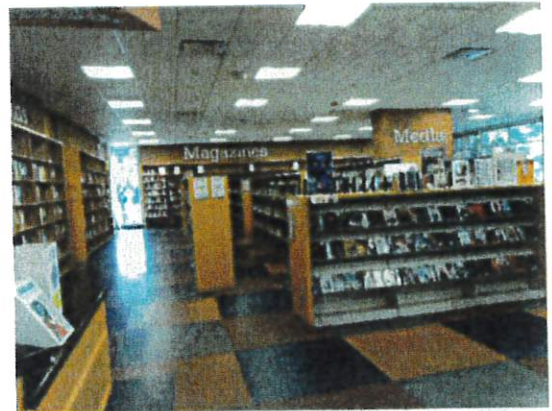
The building has a combination of fluorescent light fixture types. To increase the amount of lighting available, the lighting in the storage room off of Children Services, as well as a bank of lights in the Children's area have previously been replaced with LED fixtures. It is recommended that the existing fluorescent lighting fixtures be replaced with more energy efficient LED fixtures throughout the building.

The electrical panels as well as the primary switchgear were replaced with the 2006 renovations. It has been conveyed that there are many empty breakers to perform future updates to the lighting/IT. There appeared to be adequate clearance in from of the panels for access.

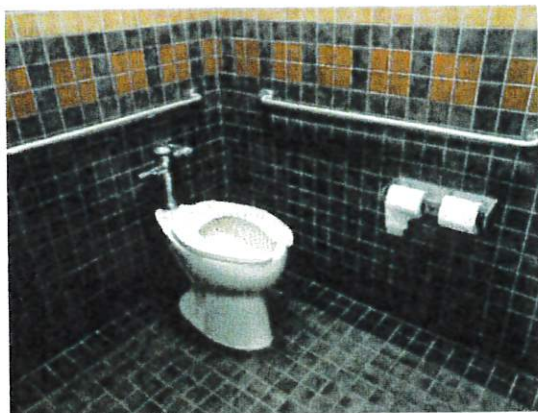
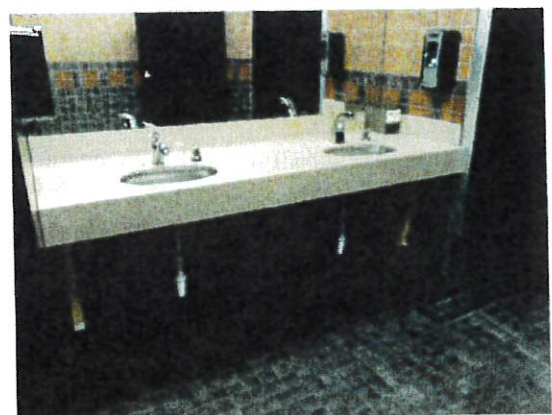
Both the main and basement levels have a men's and women's group toilet room that were fully renovated in 2006 as well as the single men's and women's toilet rooms for staff on the basement level. They remain in good condition although the under-counter panel is missing in the main level women's group toilet room and should be replaced.

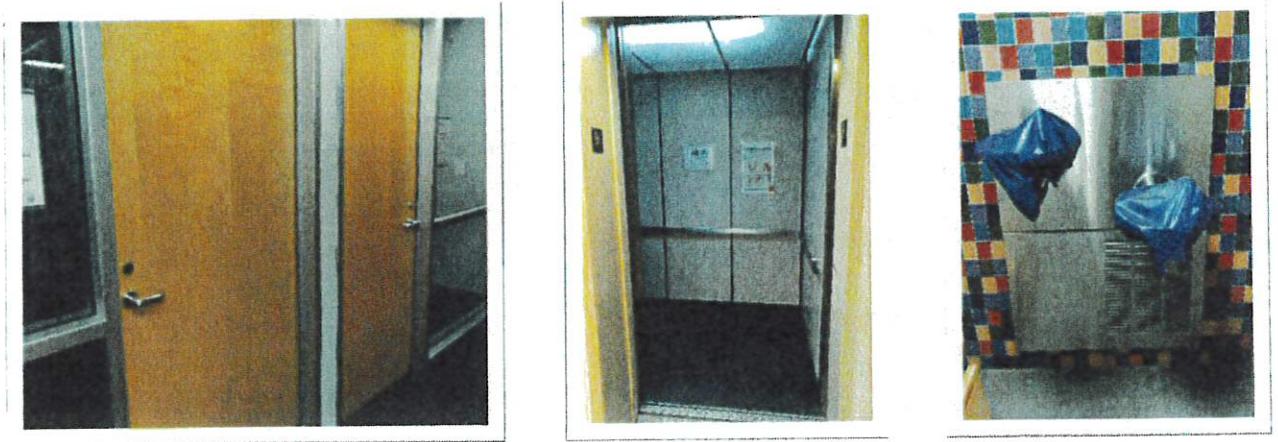
Considerations should be made to accommodate Title III Americans with Disabilities Act for commercial buildings. If services are not achievable through other means, architectural barriers should be removed to allow for access by people with disabilities.

Signage throughout the library should be evaluated for compliance with ADA 703 wherein both visual and tactile characters are required for non-temporary (7 days or less) signage. Tactile characters were not noted on the existing signage and most locations have printed signage with wall mounted slip covers.

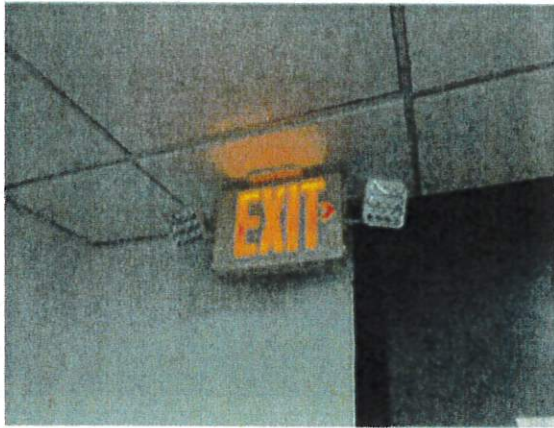
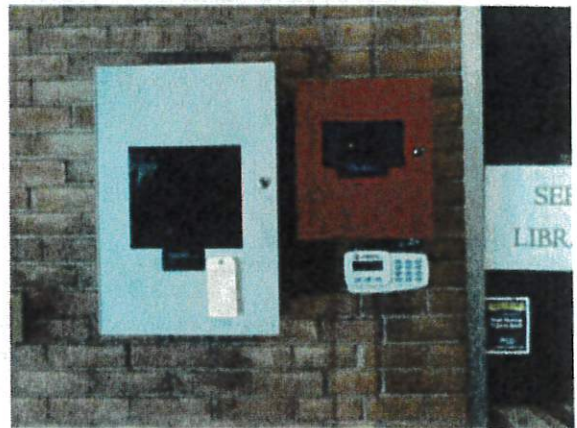
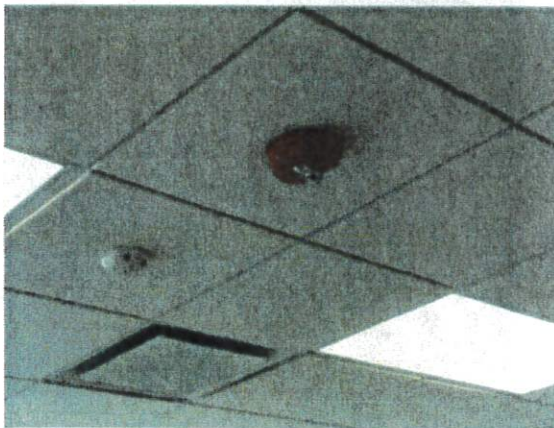
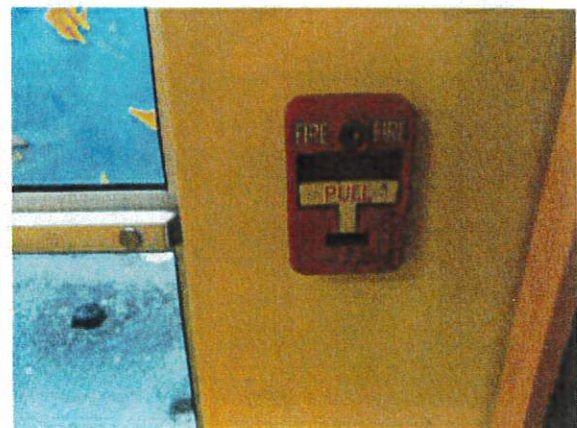
It has been conveyed that the security lighting does not function properly and should be replaced.

Fire extinguishers are also easily available and appropriately labeled.

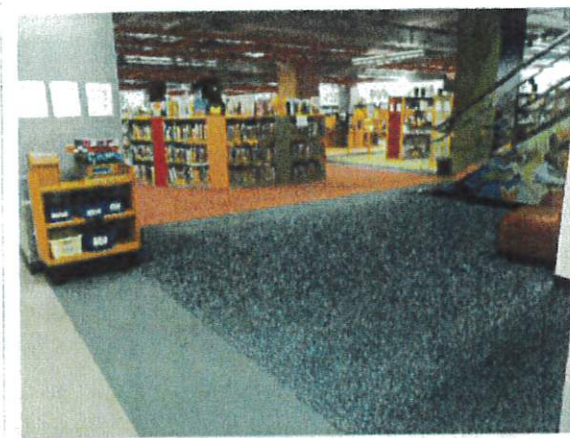
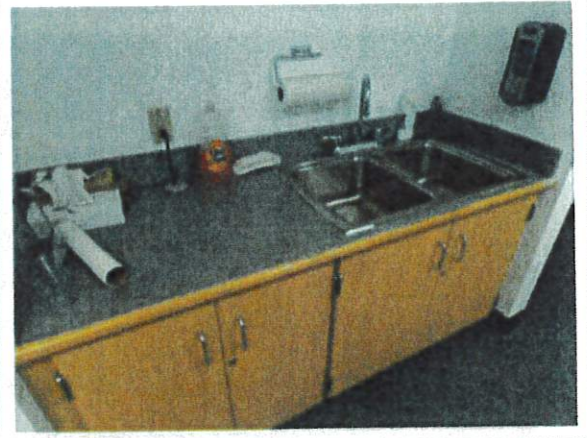
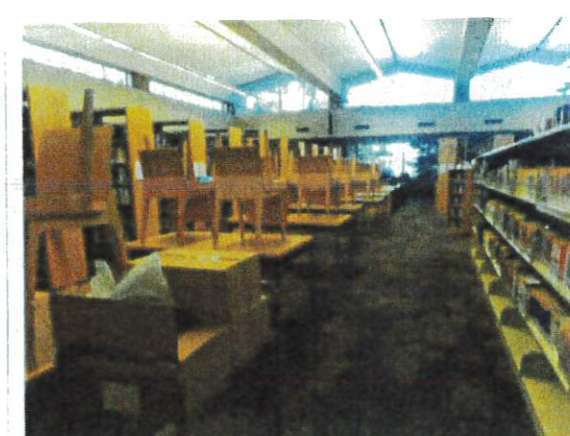
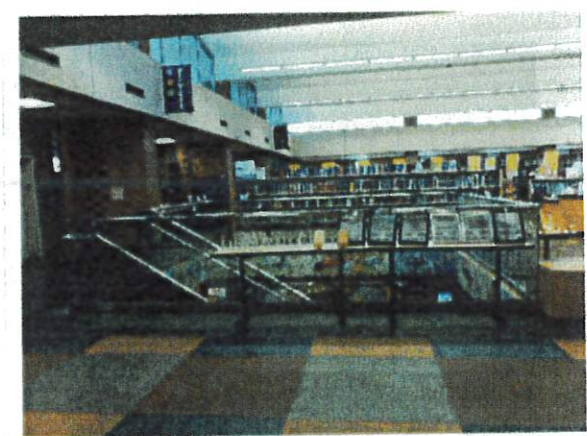
The updates that took place in the 2006 renovation remain in relatively good condition throughout the building, although normal wear and tear and useful lifespan are beginning to show.

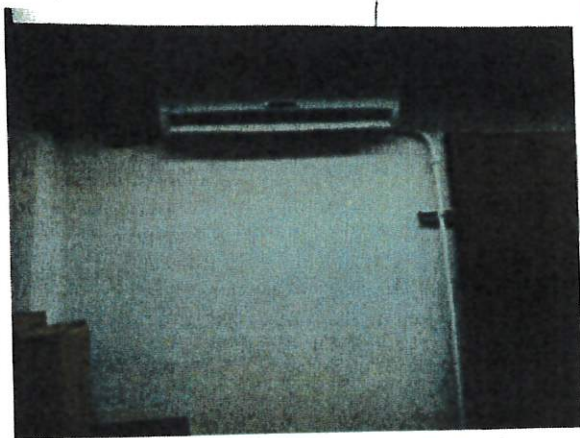
**IT / Equipment Room –
Split System Unit**
